Wellan Tel 01608 685753	Wellan House, Aylesmore, Works, CV36 5EJ
Scale NTS Proj No 14-215	Title MARK-UP OF UNSTABLE WALLS
Date APRIL '16 Drg No SK/08	Project FORMER BURGESS BUILDING CANAL STREET, BANBURY

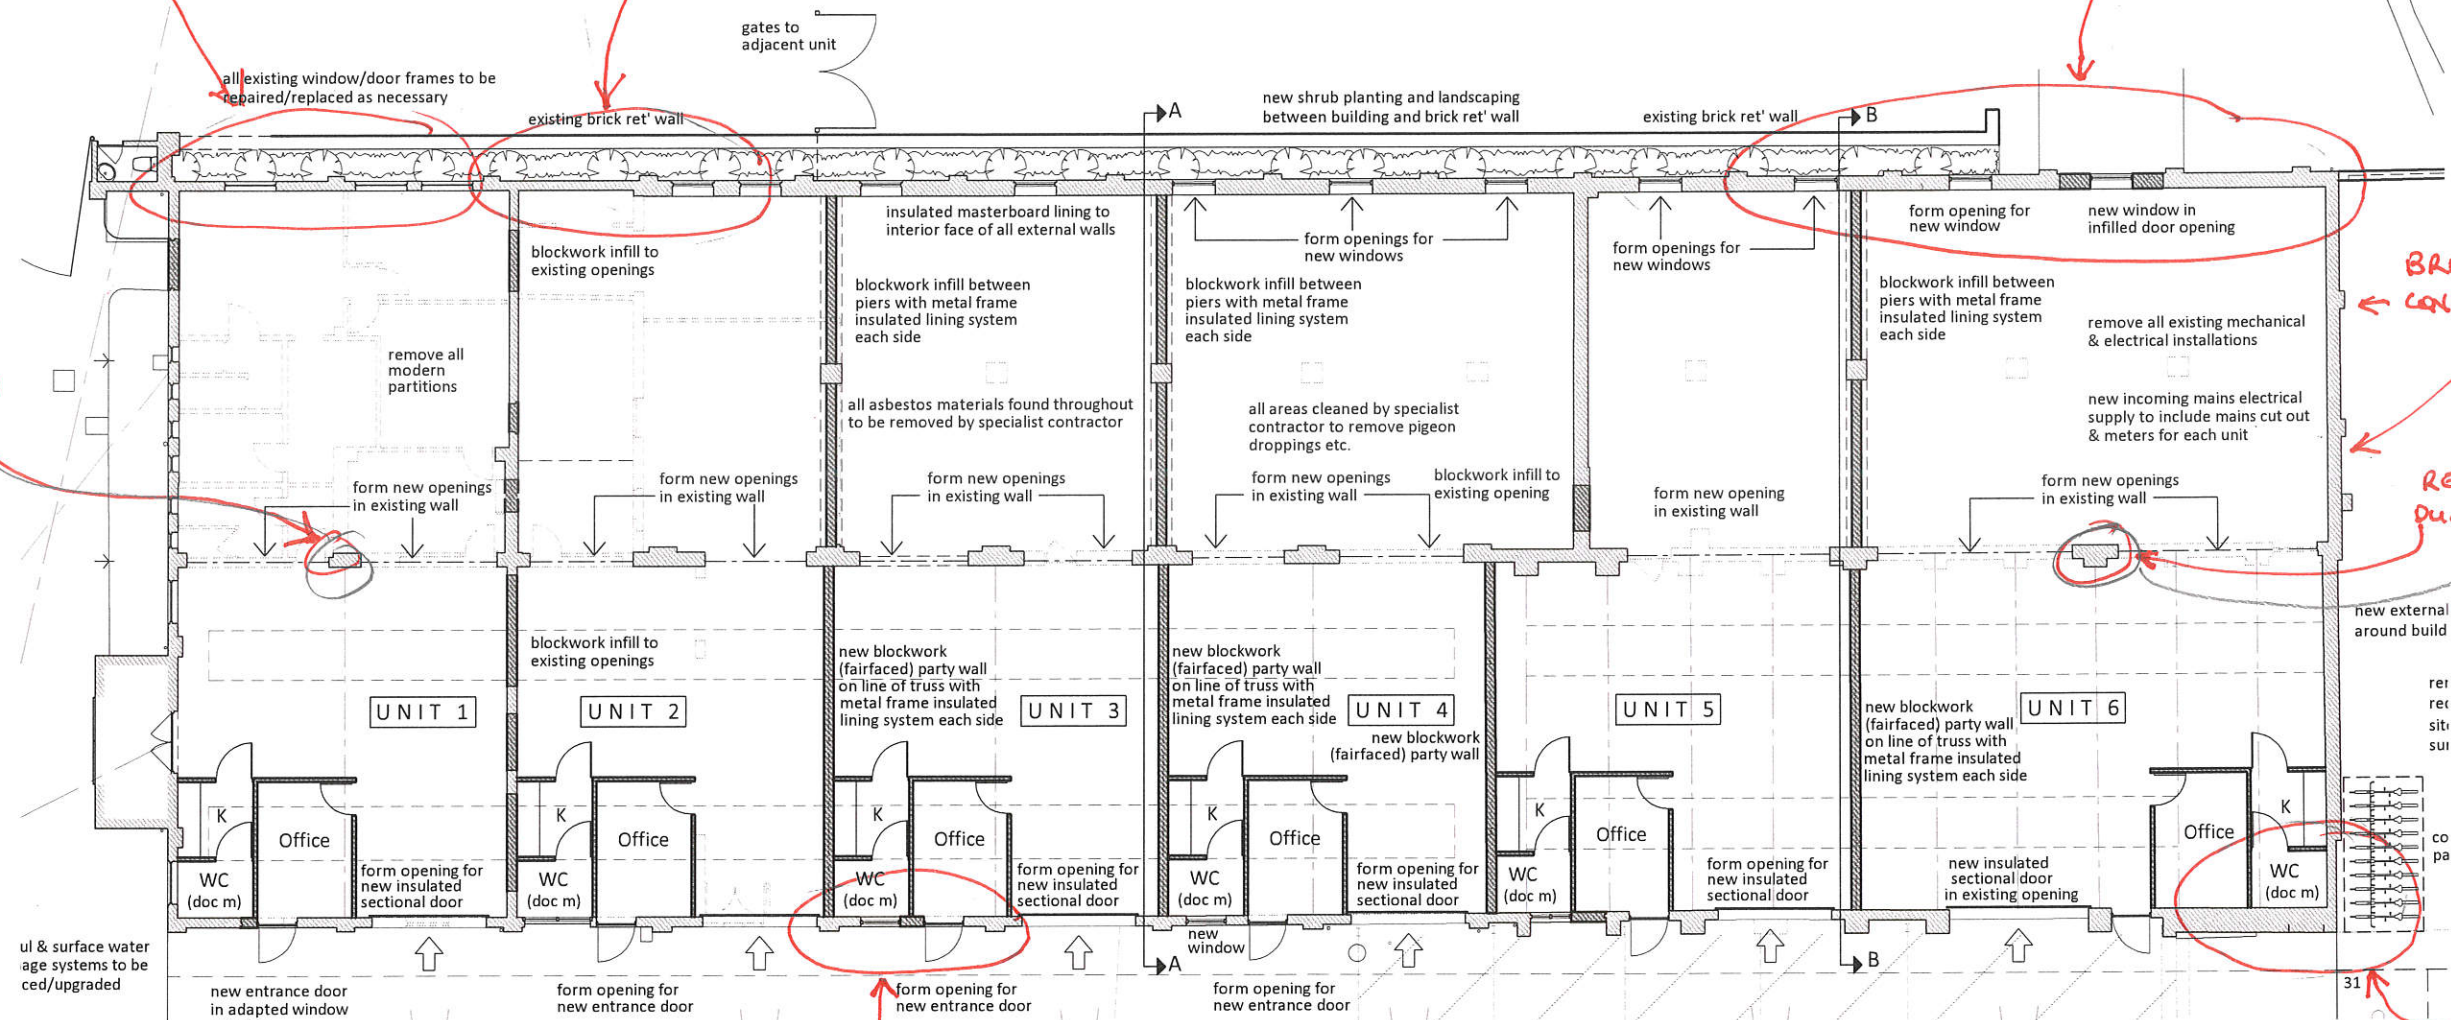
ALL OF STRUCTURE SHOULD BE REGARDED AS POTENTIALLY UNSTABLE DURING & AFTER ROOF. TEMPORARY WORKS WILL BE REQUIRED.

- 1) MANY BRICKWORK PANELS HAVE BEEN REMOVED ON SOUTH ELEVATION. OPENINGS HAVE BEEN INFILLED OR OPENINGS MADE & BRICKWORK IS IN POOR CONDITION. SOME ADDITIONAL PANELS ARE LIKELY TO REQUIRE REBUILDING.
- 2) OPENINGS TO BE MADE FOR INDUSTRIAL DOOR IN SOUTH ELEVATION WILL REQUIRE STEEL TRIMMING.

POSSIBLY REQUIRES REBUILDING

REQUIRES REBUILDING DUE TO INSTABILITY OF BRICKWORK LOCALLY.

REQUIRES REBUILDING DUE TO LEAN. DANGEROUSLY UNSTABLE WHEN ROOF IS REMOVED.

REQUIRES REBUILDING DUE TO LEAN

BRICKWORK IN POOR CONDITION

REQUIRES REBUILDING DUE TO LEAN.

REQUIRES LOCAL REBUILDING

REQUIRES REBUILDING DUE TO LEAN. (CAUSED BY ROOF COLLAPSE?)
