RAF Bicester  
Planning Brief  
**PART B 1**  
**CONSERVATION MANAGEMENT GUIDELINES**  
**DOMESTIC SITE**

RAF Bicester  
Planning Brief  
**PART B2**  
***DRAFT CONSERVATION MANAGEMENT GUIDELINES***  
**FLYING FIELD AND TECHNICAL SITE**

The buildings inspected are listed below with comments on their condition as seen. The buildings are listed in the order in which they were viewed and the degree of access to each is noted. The condition of the finishes, windows and doors is not noted except where it indicates an underlying structural problem. In general the windows are boarded up making assessment of the condition of the lintels very difficult.

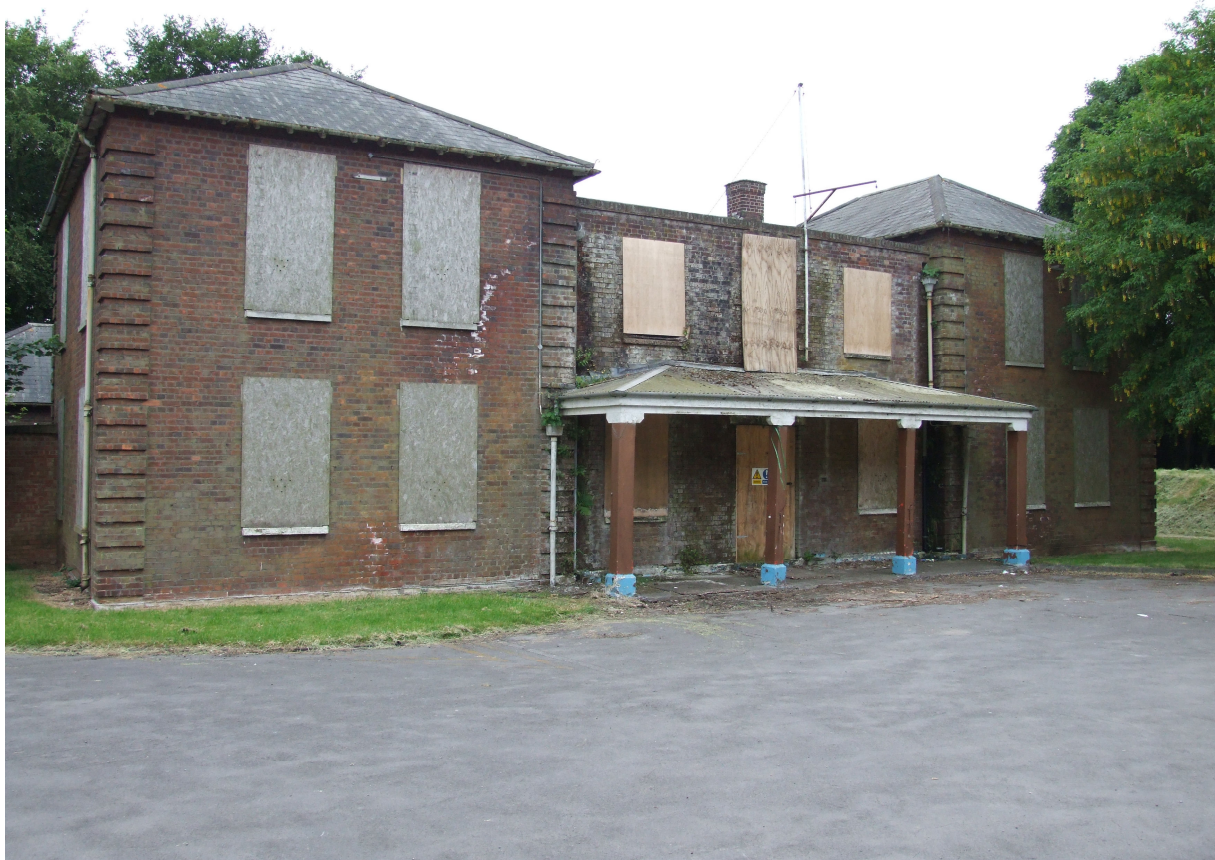
## Building 147

The Station Offices Building 147 is a two storey structure that is connected via a single storey corridor to the Operations Block Building 146 at the rear. The building has a cellar below the south west part of the building accessed from the rear. It was not possible to access this area although it was possible to see that there was a moderate depth of water flooding the basement.

The station offices building appears to be in its original form with red brickwork solid external walls that are generally in good condition. The dpc appears to have been constructed with asphalt which has deteriorated and hardened with time and which has partly been extruded from the joint in many places. The effectiveness of the dpc may have been compromised in places. The brickwork is water stained in places where rainwater handling has failed, this is noticeable at the front at the edges of the porch where the flashing detailing is very poor and the hoppers etc have been overtopping etc. The parapet to the flat roof area at the centre of the front of the building is also badly stained, with plant growth appearing in the capping. The capping detail of brick on edge over a double course of tiles appears to be failing. The lintels and cills appear to be in reasonable condition. The lime mortar is badly eroded in many of the areas affected by damp and by water overflowing from ineffective rainwater goods. The mortar is also seriously damaged in the parapet area.

The majority of the building has a shallow pitched slate covered hipped roof forming a U-shape while the front central area has a flat concrete roof behind a parapet. The condition of the slate roof is poor with slipped slates forming holes in some places. It is likely that the fixings for the slates have come to the end of their life as the holes appear to be caused by slippages not breakages of the slates. There are several roof lights / roof access points that have lost their coverings and are leaking / missing. It could be seen that the leaks in the roof have caused damage to some of the timber rafters and loft ceiling joists, particularly at the eaves. The ridge and hip capping appear to be intact but uneven suggesting that the bedding is failing, the condition of the valleys could not be

seen but is expected to be poor considering the leaks inside. The brick chimney is in reasonable condition although it was not possible to view the flashing. The guttering, down pipes and hoppers are in very poor condition.

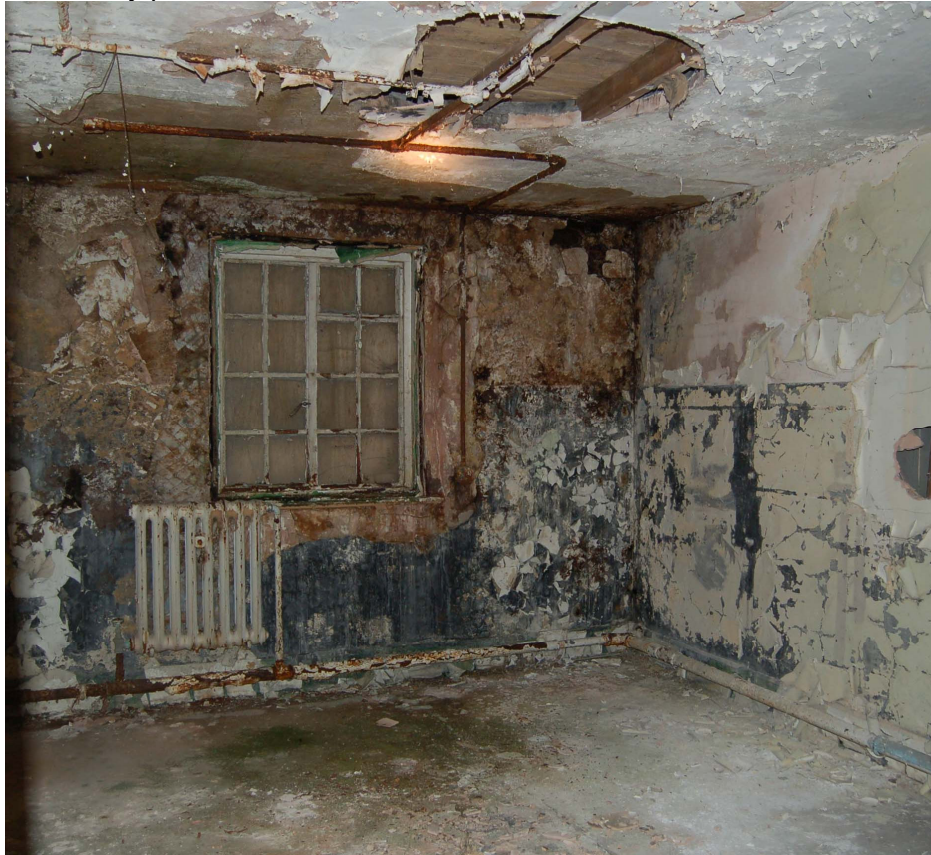
The concrete flat roof area is in very poor condition. There is an opening in the roof with no covering. There is also a circular hole in the roof of the central front second floor room that is reported to have housed a camera obscura. The hole is effectively closed off. The underside of the concrete roof has several areas where the concrete is spalling revealing rusting reinforcement. The concrete was very damp with mould and staining indicating continuously damp conditions. It is assumed that the finish to the concrete roof, which was not viewed, would have been asphalt that has now become brittle, cracked and failed.

The inside of the front external wall on both storeys below the flat roof area was very damp with plant roots showing on the face this also affected the adjacent internal walls for part of their length. Otherwise the internal walls and internal faces of the external walls show little signs of damp, apart from areas affected by rain ingress through the roof openings and other damaged areas of roof. The ground and first floors appear to be solid concrete generally with a timber boarded finish in very poor condition. As far as could be seen the concrete floors were in reasonable condition. The stair is constructed in concrete with a very thin section, this appears to be in acceptable condition. No significant cracking was observed in the internal walls or the internal face of the external walls. Lintels and beams appear to be in satisfactory condition. Damage was observed to the lath and plaster top floor ceilings where the roof is leaking above. The decorative finish of the interior is extremely poor in every room.

There is a large porch built off the front of the building. The frame to the porch appears to be in reasonable condition but the covering is relatively modern and is in poor condition.

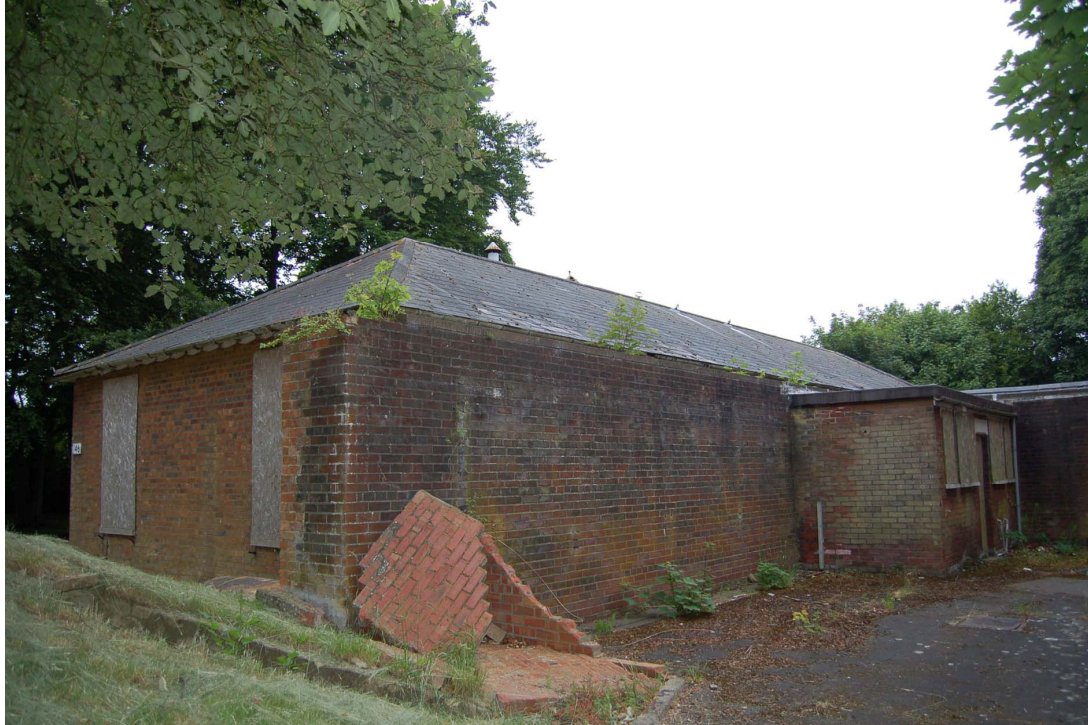
### **Building 146**

The Operations Block Building appears to be in its original form with red brickwork solid external walls that are generally in good condition. The dpc appears to have been constructed with asphalt which has deteriorated and hardened with time and which has partly been extruded from the joint in many places. The effectiveness of the dpc may have been compromised in places. The parapet to the flat roof area over the west room that is almost separated from the main block is damp and stained in places. The concrete capping detail to the small length of parapet round the flat roof appears to be generally sound. The lintels and cills appear to be in reasonable condition. The lime mortar is badly eroded in many of the areas affected by damp and by water overflowing from ineffective rainwater goods. The mortar is also seriously damaged in the parapet area.

The majority of the building has a shallow pitched slate covered hipped roof while the north west side has a flat roof and west end room probably has a flat roof behind a parapet. The condition of the slate roof is poor with slipped slates forming holes in some places although work has been done to patch some areas. It is likely that the fixings for the slates have come to the end of their life as the holes appear to be caused by slippages not breakages of the slates. There are several vents and other penetrations of the roof with very poor flashing detailing which is causing local leaks. It could be seen that the leaks in the roof have caused damage to some of the timber rafters and ceiling joists, particularly at the eaves. The ridge and hip capping appear intact but uneven suggesting that the bedding is failing. Neither the roof over the west end room nor the flat roof to the north west rooms could be viewed. The roof to the link corridor with Building 147 appears satisfactory. The guttering, down pipes and hoppers are in very poor condition.

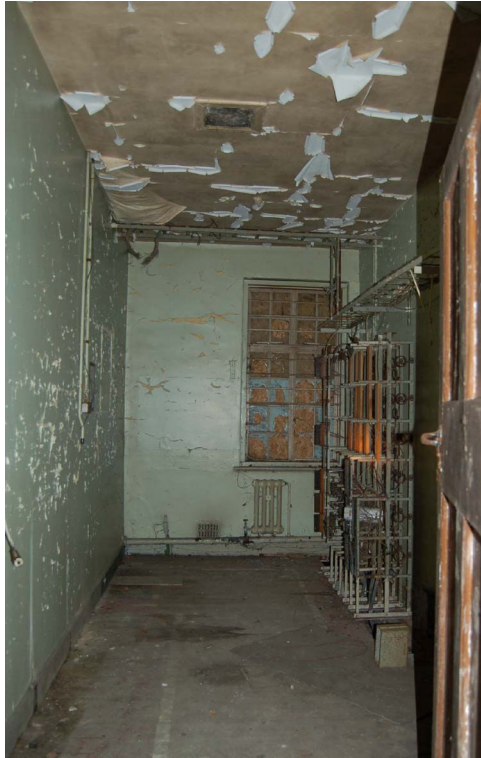
The internal walls and internal faces of the external walls show little signs of damp, apart from areas affected by rain ingress through damaged areas of roof. The ground floor appears to be solid concrete generally with a timber boarded finish in very poor condition. As far as could be seen the concrete floor is in reasonable condition. No significant cracking was observed in the internal walls or the internal face of the external walls. Lintels and beams appear to be in satisfactory condition. Damage was observed to the lath and plaster ceilings where the roof is leaking above.

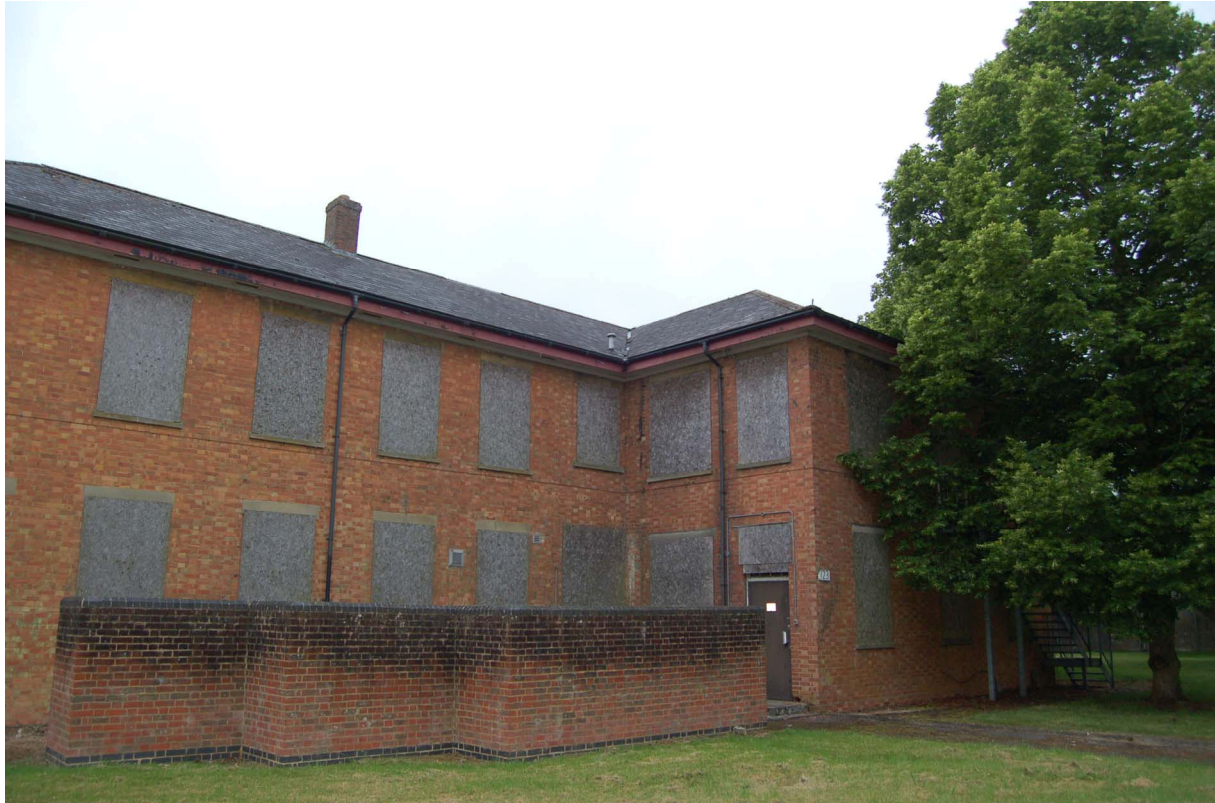
### **Building 123**

The Station Armoury and Lecture Rooms Building appears to be mainly in its original form with red brickwork solid external walls apart from a small section at the east end of the single storey section which has been added relatively recently. The walls of the two storey section are in good condition. The dpc appears to have been constructed with asphalt which has deteriorated and hardened with time and which has partly been extruded from the joint in many places. The walls of the single storey section are generally in good condition apart from where they are affected by the damp penetrating from the roof area to the masonry below the parapet where there is water staining and damage to the mortar. The parapet to the flat roof area over the east single storey section is constructed in engineering brick that appears to be in reasonable condition however there are areas where plants are growing out of the mortar coursing. The capping detail to the parapet walls is a special blue brick on edge and appears satisfactory. The lintels and cills appear to be in reasonable condition as viewed from the outside. However the lintels over the openings in the south face of the single storey section appear to be deteriorating when viewed from inside. Damp appears to be penetrating through the parapet and the wall below the parapet, this moisture is reaching the head of the lintels and appears to be causing damage with considerable rust staining around the area. The south facing wall of the single storey section is very damp throughout its height. The chimney in the two storey section appears to be in satisfactory condition. The walls forming the stairwell down to the basement is in poor condition with cracks and spalling detectable. The cellar stairwell retaining walls are very damp with moss and plant growth between the courses. The mortar is generally in reasonable condition except in the cellar stairwell where it is seriously damaged.

The two storey section of the building is T-shaped and has a shallow pitched slate covered hipped roof. The condition of the slate roof is moderate with slipped slates observed from the outside. It is

likely that the fixings for the slates have come to the end of their life as the holes appear to be caused by slippages not breakages of the slates. There appear to be just a few leaks from the slate roof. The ridge capping is missing in places and the hip capping appears intact but uneven suggesting that the bedding is failing. The valleys appear sound. The flashing to the chimney appears to be in reasonable condition. It is likely that the some of the minor leaks in the roof may have caused damage to some of the timber rafters and ceiling joists. The guttering, down pipes and hoppers are in moderate condition.

The single storey east end of the building has an asphalt covered flat roof with parapets all round. The asphalt is old, cracked and has failed in numerous places. The most obvious failures are in the upstand of the asphalt on the inside of the parapet walls. In many areas these have cracked and fallen away from the parapet creating a scoop to direct water to the base of the parapet and the top of the concrete roof slab underneath the asphalt waterproofing. The flat roof covering was not inspected in detail so it is not possible to be sure if it has failed in every location, however it would appear likely that this is the case. The hoppers and down pipes are in moderate condition.

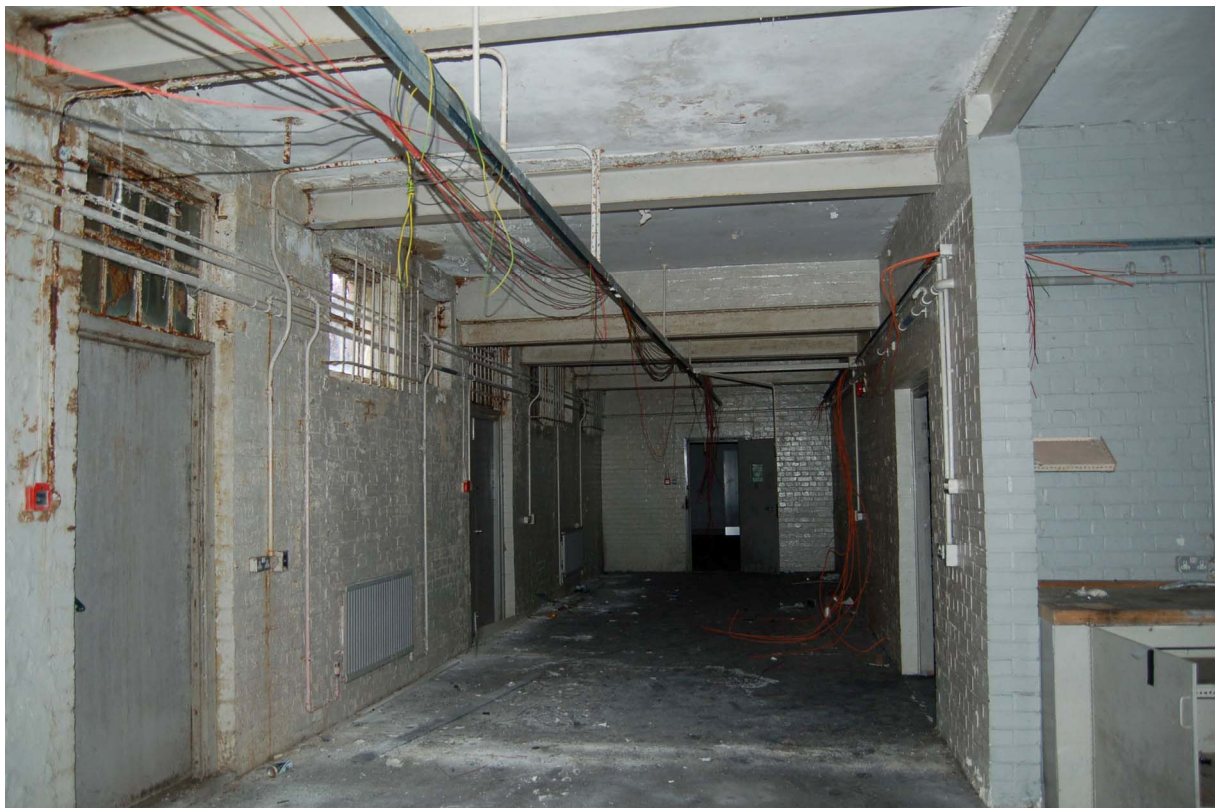
The internal walls and internal faces of the external walls show little signs of damp in the two storey part of the building. The ceilings and floors of this part of the building are generally in reasonable condition apart from one room that overlooks the flat roof where the finishes are generally mouldy. The stair is constructed in concrete with a very thin section, this appears to be in acceptable condition. In contrast the inside faces of the external walls in the single storey part of the building are generally damp and in poor condition. The ground floor appears to be solid concrete and in moderate condition. No significant cracking was observed in the internal walls or the internal face of the external walls. Lintels and beams appear to be in satisfactory condition in general but are in poor condition below the parapets on the south side as mentioned above, steel beams are built into the walls in this location and these are likely to be rusting. The finishes in the single storey section are generally painted only and in moderate or poor condition. Some of the windows in the single storey section below the parapet area have metal grilles fixed over the inside. These are corroding where they are built into the walls and beginning to cause damage to the walls.

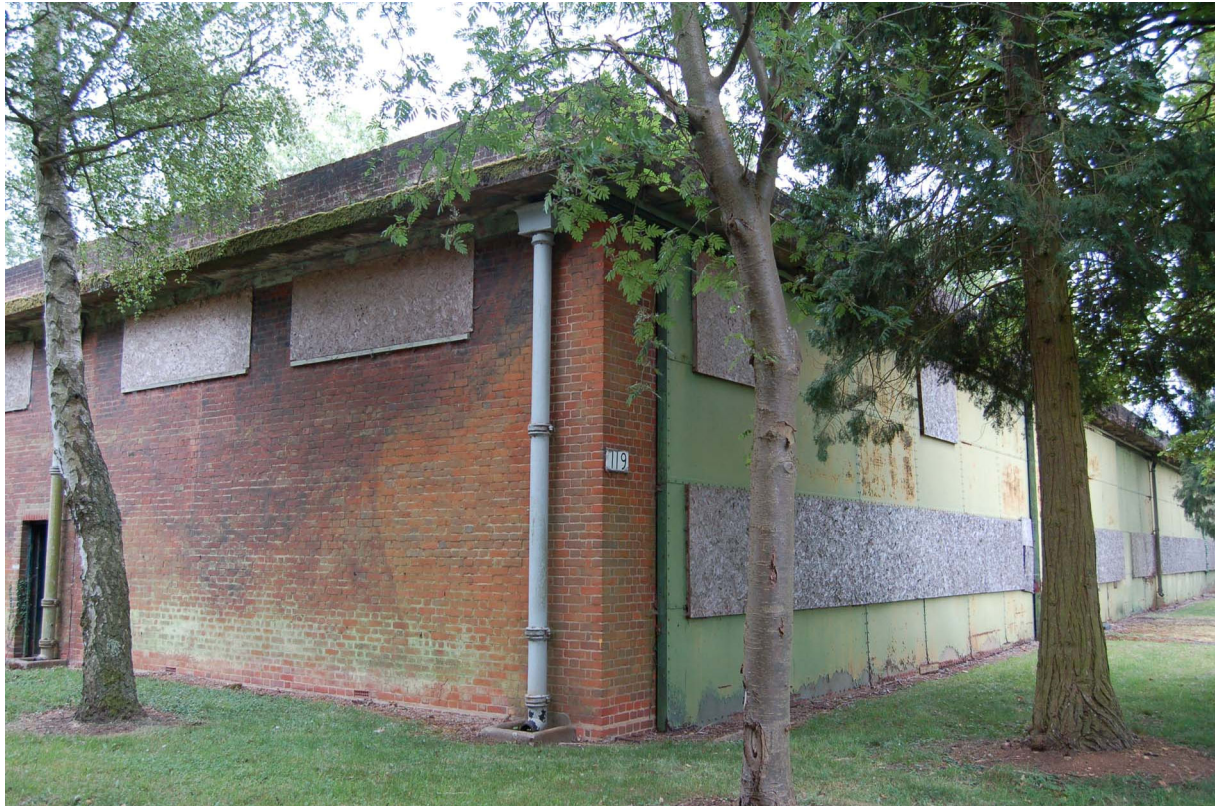
### Building 119

The Fire Fighting Mechanical Transport (FFMT) shed appears to be in its original form with red brickwork solid external end walls. The lower part of the side walls are openings with three large doors down each side, the upper part of the walls is a masonry parapet wall which is supported by a large concrete beam and overhanging band that runs all round the building. The end walls are in reasonable condition apart from the staining due to the rainwater overflowing from the three hoppers and down pipes at each end. The masonry parapet wall above the concrete band is generally in poor condition and there are areas where plants are growing out of the mortar coursing. There does not appear to be a special capping detail to the parapet walls and the tops are seriously damaged by frost. The concrete band course and overhang are in poor condition throughout with spalling of the top surface and staining of the underside in all locations. The mortar is generally in reasonable condition below the concrete band and in poor condition above.

The building has two shallow pitch duo-pitch roofs with hipped ends and with a valley gutter between, the roofs are formed of slate. There is also a valley all round the roof behind the parapet wall. The roof was not visible from the outside. The inside of the roof is lined with timber boarding. Several holes were observed in the roof mainly near the central valley. The roof is supported by a light weight steel truss arrangement supported on a deep steel beam under the valley. The truss members appear to be in reasonable condition generally but there was damage near the leaking areas of roof. The valley beam is damaged in places by the leaking roof. The roof is divided into several bays with columns on the outside edges and valley. The columns are formed from steel channel sections facing each other infilled with concrete. There is corrosion at the base of several of the columns. The rainwater is lead via the valleys to hoppers and down pipes, these are in moderate condition but are ineffective in most cases as the leadwork does not lead the water into the hopper and most is running down the walls.

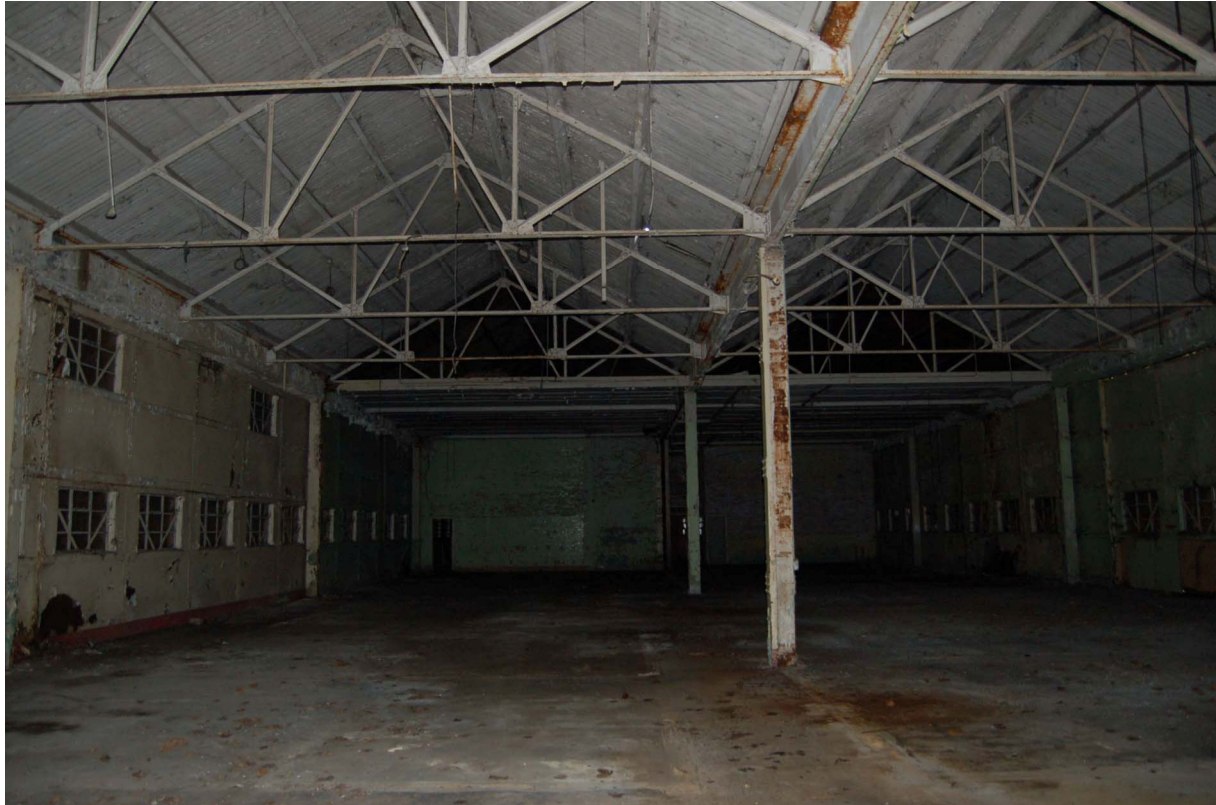
The main doors down each side used to open one at a time. The east doors have been fixed shut and the central door has been taken off its track so that all the doors are in line. The west doors are still in their original places but do not look as if they could move. The doors are formed with a steel frame and cladding with a line of glazing top and bottom. The condition of the doors is very poor and they will need major refurbishment. The bottom tracks are very damaged.

There are a couple of internal walls at the south end subdividing the space. The condition of the internal walls and internal faces of the external walls is moderate and were generally damp. The floor is solid concrete and in reasonable condition. No significant cracking was observed in the internal walls or the internal face of the external walls. Lintels to some of the windows in the south end elevation show spalled concrete and rusting reinforcement while the remainder were generally damp suggesting similar problems. The whole of the inside of the building has a painted finish that is in poor condition.

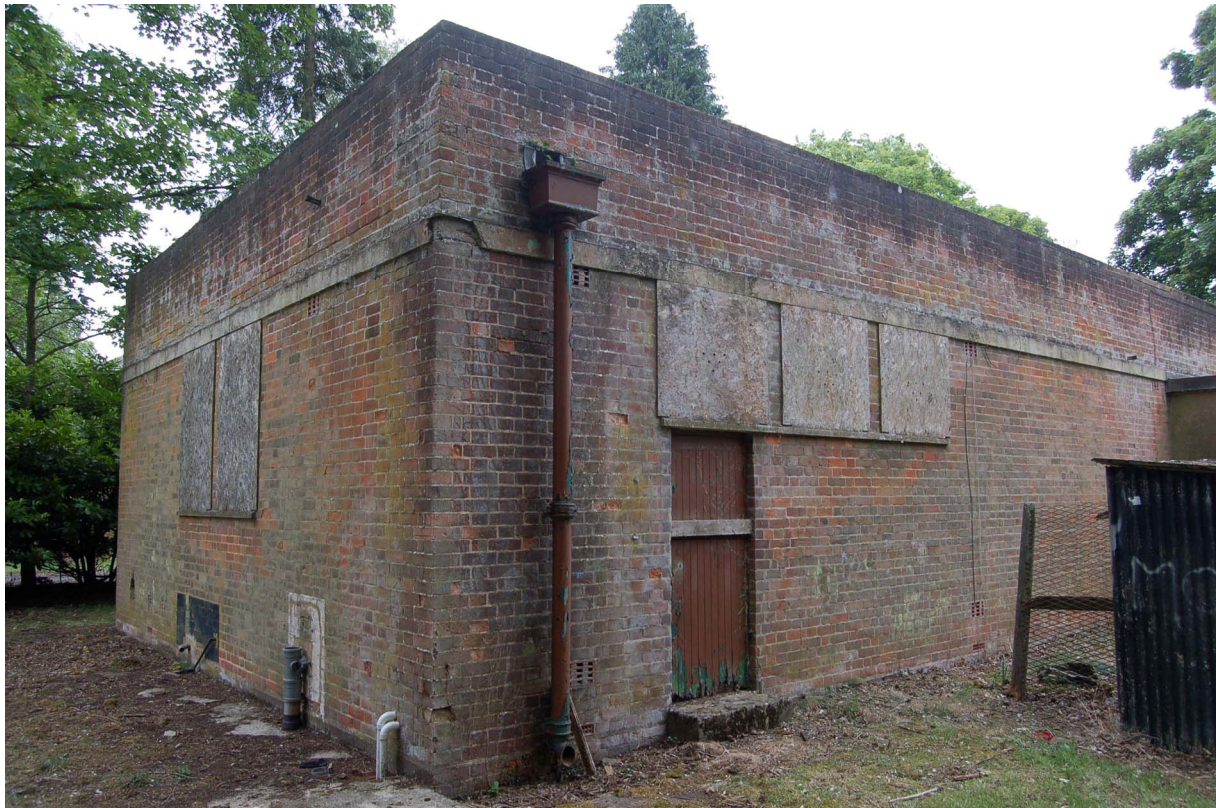
### **Building 103**

The Link Trainer Building appears to be mainly in its original form with red brickwork solid external walls apart from the entrance area which has rendered masonry walls. The main part of the building has a concrete band at flat roof level with a brick parapet wall above. The lower parts of the walls of the main section are in moderate condition although there is some water staining and there are some frost damaged bricks. The parapet walls above are in poor condition. There are stepped cracks in some of the masonry at the parapet corners. There does not appear to be a special capping detail to the parapet walls and the tops are seriously damaged by frost. There are areas where plants are growing out of the parapet mortar coursing. The concrete band course is in poor condition throughout with spalling of the surface in many locations with rusting reinforcement exposed in some areas. The mortar is generally in reasonable condition below the concrete band and in poor condition above. The rendered entrance is in moderate condition with some poor areas where there is spalling and cracks. The concrete cills of some of the windows are damaged and spalling.

The flat roof to the main building could not be viewed. However the rainwater is lead to hoppers and down pipes, these are in moderate condition but they have overflowed in the past. The flat roof to the entrance appears to be of asphalt but it could not be inspected.

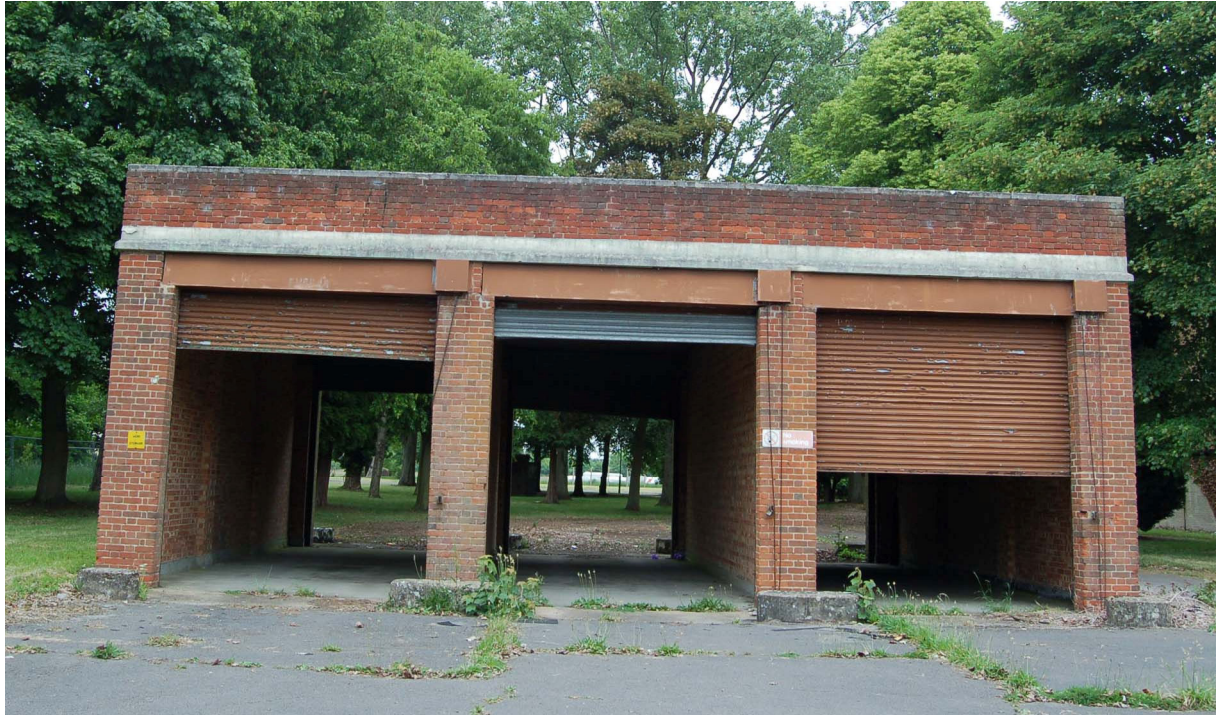
### **Building 105**

The Petrol Tanker building appears to be mainly in its original form with red brickwork solid external walls and has three large garages with doors at both end of each garage. The walls have a concrete band at flat roof level with a brick parapet wall above. The lower parts of the walls are in moderate condition although there is some diagonal stepped cracking at both ends of the south western face and there are some frost damaged bricks. The parapet walls above are in poor condition. There does not appear to be a special capping detail to the parapet walls and the tops are seriously damaged by frost. There are areas where plants are growing out of the parapet mortar coursing. The concrete band course has a small projection to throw off water at the lower edge. The concrete is in poor condition throughout with spalling of the surface in several locations with rusting reinforcement exposed in some areas. The mortar is generally in reasonable condition below the concrete band and in poor condition above.

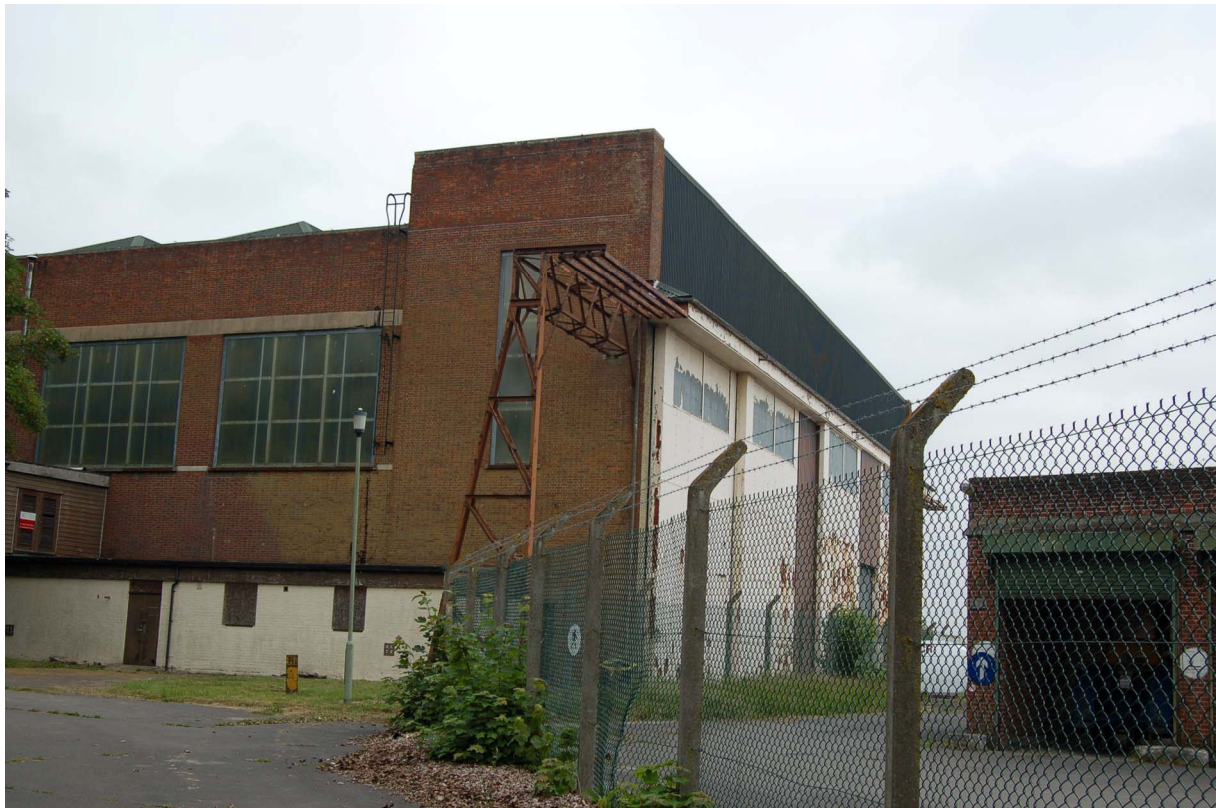
### **Building 108**

The Type C Aircraft Hanger appears to be in its original form with red brickwork solid external side walls. The lower part of the end walls are openings with six large doors each end, the upper part of the walls is a parapet wall which is supported by a large beam and overhanging band. The side walls are in reasonable condition. The masonry parapet wall above the concrete band is generally in reasonable condition. There appears to be a concrete capping detail to the parapet walls that look from the distance to be deteriorating. There is a concrete band course that is in moderate condition. There are large sections of glazing down the sides and these appeared to be in moderate condition.

The main doors at each end have been modified so that they no longer open fully as the outriggers to support them have not been maintained. The doors are formed with a steel frame and full height cladding on the outside with half height cladding inside. The condition of the doors is moderate with some corrosion that needs treatment and repainting. The bottom tracks are in reasonable condition. The outriggers that used to support the open doors are in poor condition and need corrosion treatment to remain standing.

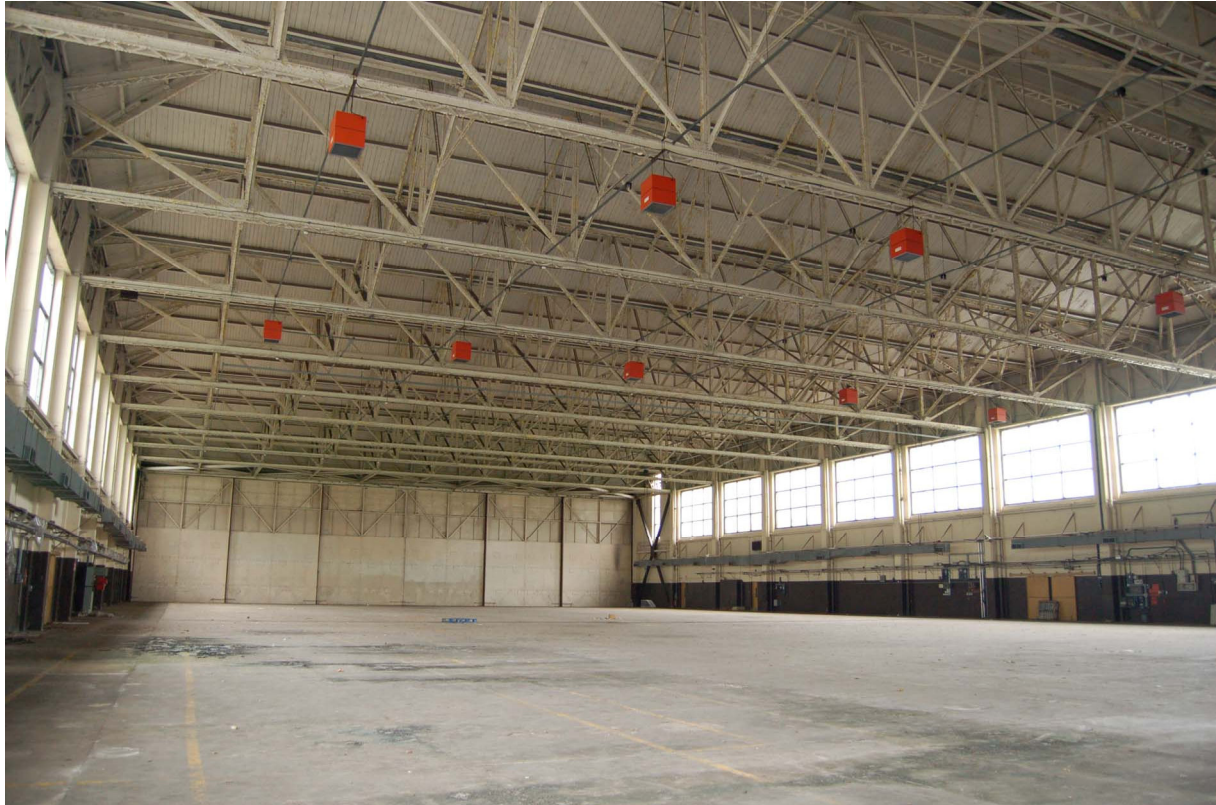
The condition of the internal faces of the external walls is good. The whole of the interior of the hangar is painted, the paintwork is in good condition on the walls and moderate condition on the underside of the roof. The floor is solid concrete and in good condition.

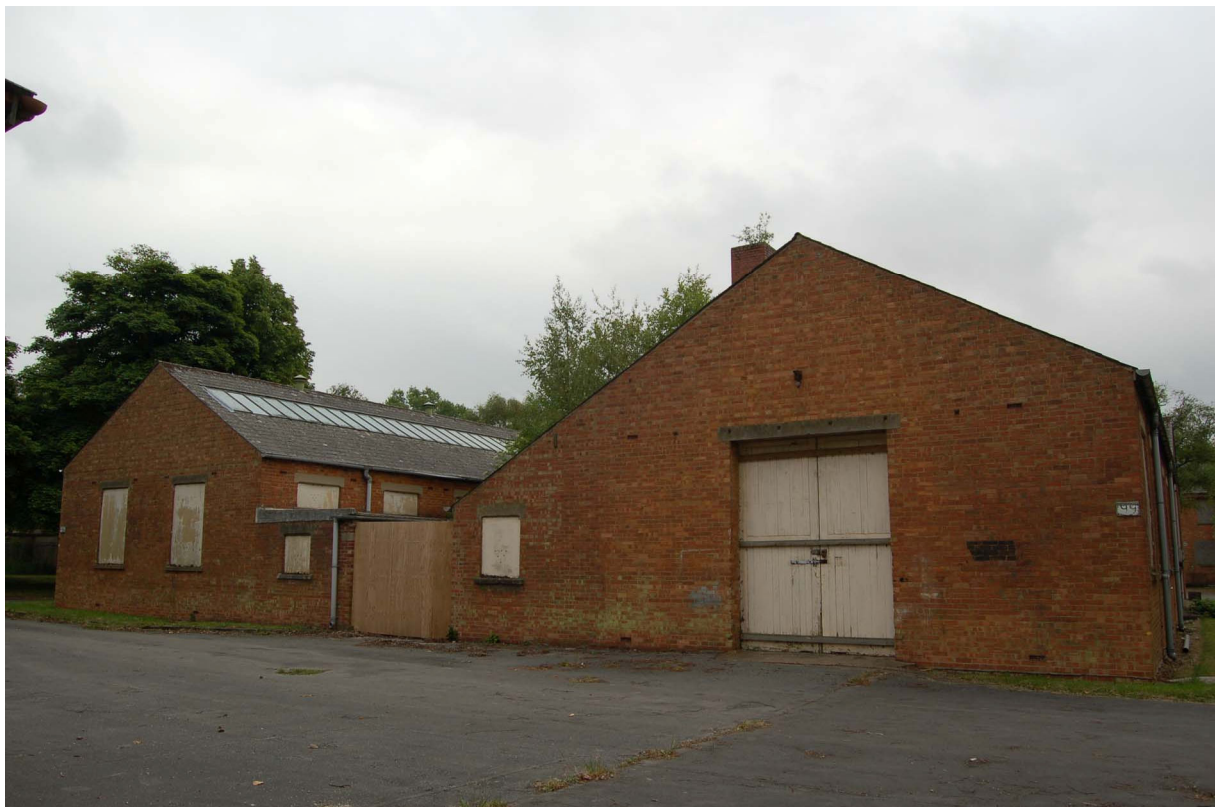
### **Building 99**

The Main Workshop Building appears to be in its original form with red brickwork cavity construction external walls that are generally in good condition, however there is some impact damage near the south east corner. The masonry walls to the courtyard appear to be in solid construction and in very poor condition, water leaking from above has reached steel grille items built into the masonry which are now rusting and lifting the masonry and roof above. The dpc appears to have been constructed with asphalt which has deteriorated and hardened with time and which has partly been extruded from the joint in many places. The effectiveness of the dpc may have been compromised in places. There is a flat roof area near the middle of the building that it is believed has a parapet wall but this was not visible. The lintels and cills appear to be in reasonable condition in most areas but a few lintels showed signs that damp penetration was affecting the concrete with evidence of spalling at the bottom, some concrete cills are deteriorating with sections missing of the face and underside. The lime mortar is badly eroded in some areas affected by damp and by water overflowing from ineffective rainwater goods. There are two brick chimneys, these could only just be seen but they appear to be in poor condition with plants growing from the tops and evidence of deterioration of the brickwork, it was not possible to view the flashing, although evidence from inside suggests that the flashing must be damaged.

The majority of the building has a shallow pitched slate covered hipped roof forming a U-shape while the lower central courtyard area has some flat concrete roofs. The roofs over the main spaces have lightweight steel trusses supporting timber purlins and boards. The truss members appeared to be in reasonable condition generally but there was damage near the leaking areas of roof. The main spaces have continuous glazed rooflights on both pitches covering about one third of the roof slope. The condition of the slate roof is moderate with a few slipped slates forming holes in some places. It is likely that the fixings for the slates have come to the end of their life as the holes appear

The concrete flat roof areas are in very poor condition. The concrete appears to have an asphalt finish that has failed and water is penetrating the concrete roofs. This is sufficiently bad to affect the walls below. The underside of the concrete roof has several areas where the concrete is spalling revealing rusting reinforcement. The concrete was very damp with mould and staining indicating continuously damp conditions. Steel beam sections support one section of flat roof in the centre of the building which shows signs of continual damp penetration that is beginning to damage the steel beams.

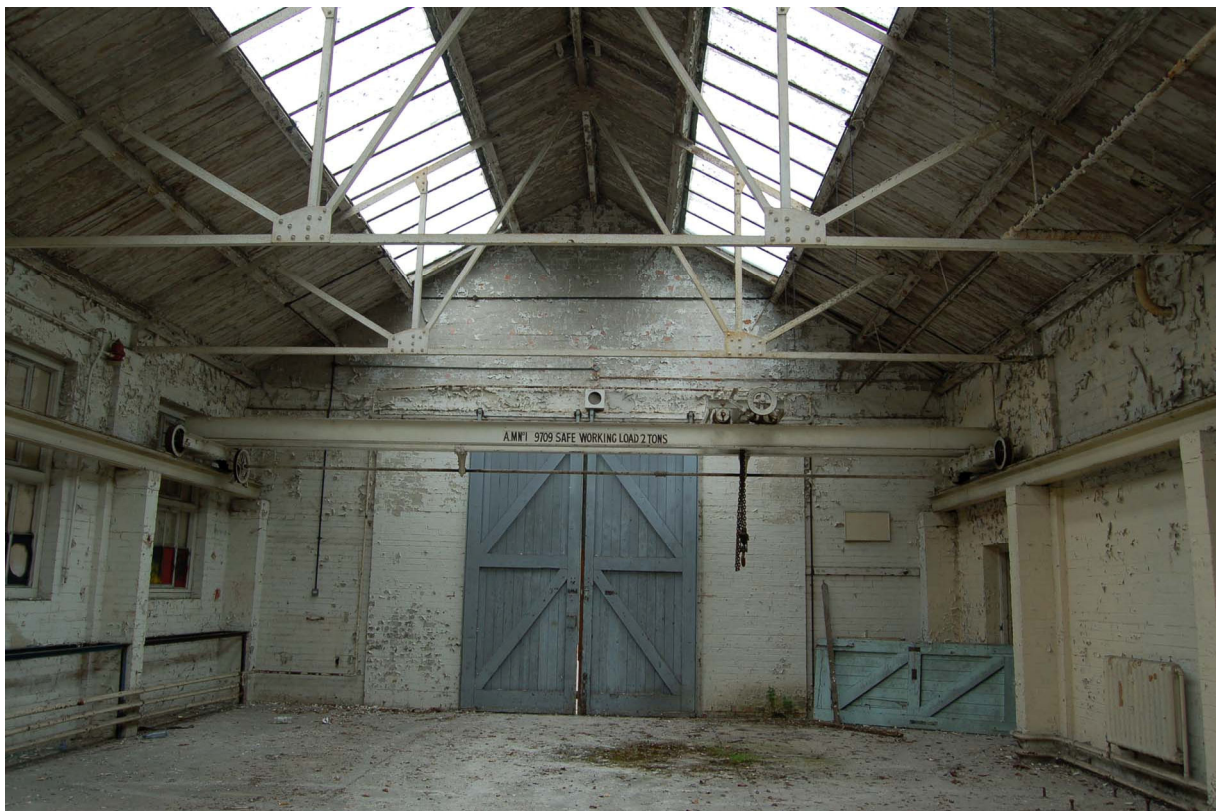
The condition of the internal faces of the external walls is reasonable except in areas where there is damp penetration e.g. below the valley gutters. The whole of the interior of the building is painted, the paintwork is in poor condition throughout. The floor is solid concrete and in reasonable condition although one space has a parquet floor in poor condition over the concrete. The tree and other plants should be removed from the courtyard.

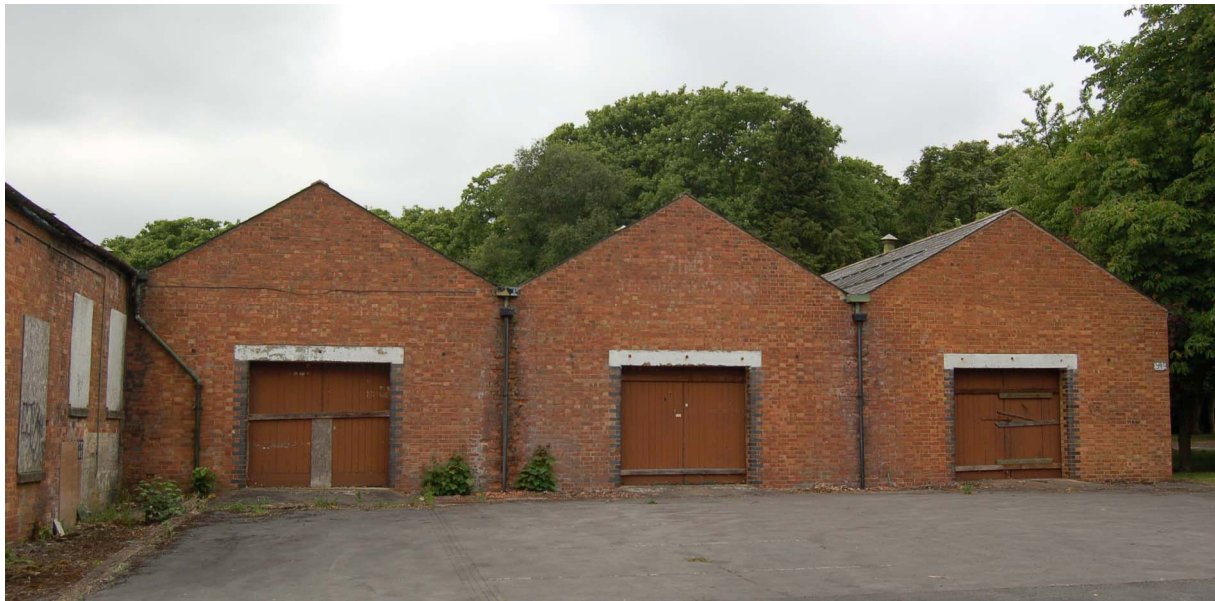
### **Building 90**

The Main Stores Building appears to be in its original form with red brickwork cavity construction external walls that are generally in good condition. There is some impact damage to the south east corner of the main block with diagonal cracks and one missing brick. There is a vertical crack from the lintel of the opening adjacent to the south east corner. The smaller attached north part of the building has solid masonry walls that are in good condition. The dpc appears to have been constructed with asphalt which has deteriorated and hardened with time and which has partly been extruded from the joint in many places. The effectiveness of the dpc may have been compromised in places. The masonry has moved horizontally on the dpc due to thermal expansion but this is not a serious structural issue. The lintels and cills appear to be in reasonable condition in most areas but a few lintels showed signs that damp penetration was affecting the concrete with evidence of spalling at the face. The lime mortar is badly eroded in some areas affected by damp and by water overflowing from ineffective rainwater goods.

The main part of the building has a shallow pitched slate covered hipped roof forming a U-shape with a long thin area of flat concrete roof in the centre. The north part of the building has three duo pitched slate roofs connected by valleys. All the pitched roofs have lightweight steel trusses supporting timber purlins and boards. The truss members appear to be in reasonable condition generally but there was damage near the leaking areas of roof. The main spaces have continuous glazed rooflights on both pitches covering about one third of the roof slope. The condition of the slate roof is moderate with a few slipped slates forming holes in some places. It is likely that the fixings for the slates have come to the end of their life as the holes appear to be caused by slippages not breakages of the slates. The roof lights have been maintained recently but they are a cause of leakage and require further work to produce a permanent solution. The valleys are generally in a poor condition with leaks in all of them. It could be seen that the leaks in the roof have caused damage to some of the timbers, particularly at the valleys. The ridge and hip capping appears to be intact and in reasonable condition. The guttering, down pipes and hoppers have been replaced in a few places but the majority are in poor condition.

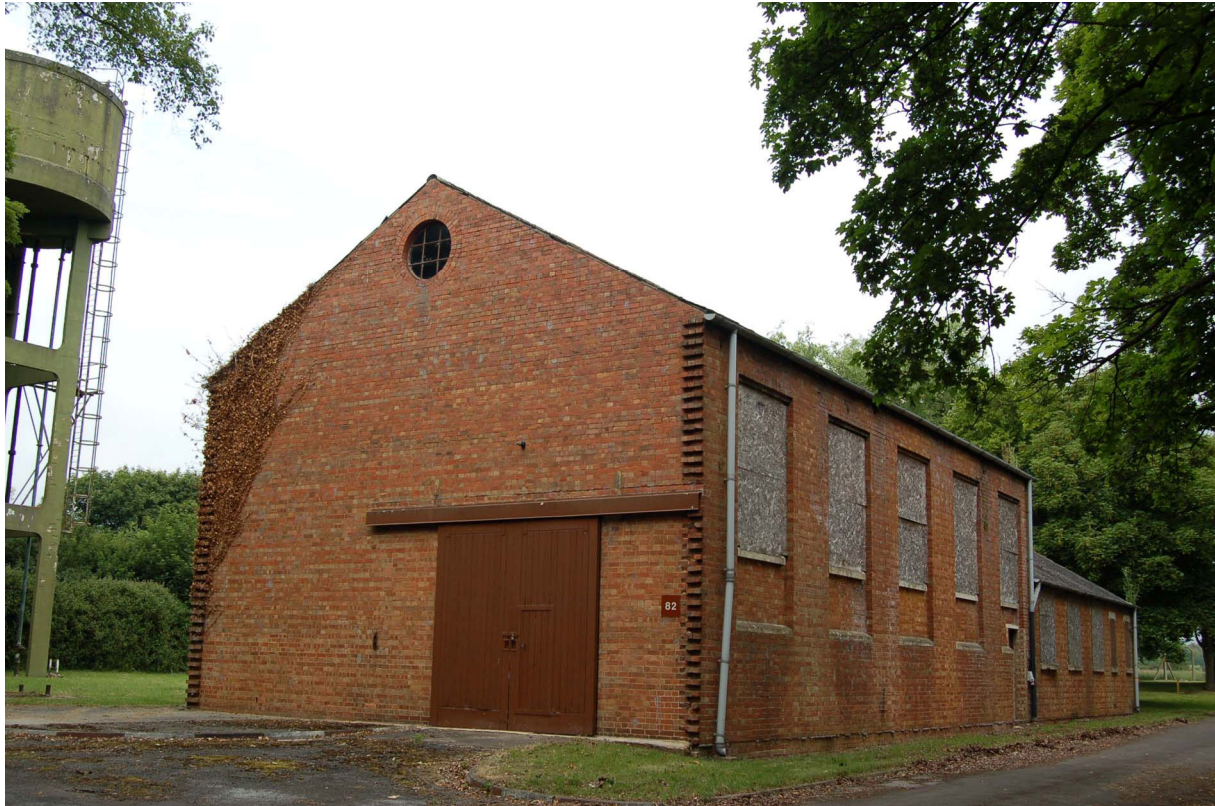
The Power House appears to be in its original form with red brickwork cavity construction external walls that are generally in poor condition. The brickwork is seriously affected by water and frost damage causing spalling of large areas. The dpc appears to have been constructed with asphalt which has deteriorated and hardened with time and which has partly been extruded from the joint in many places. The effectiveness of the dpc may have been compromised in places. The lintels and cills appear to be in moderate condition in most areas but a few lintels showed signs that damp penetration was affecting the concrete with evidence of spalling at the face, some concrete cills were deteriorating with sections missing of the face and underside. The lime mortar is badly eroded in some areas affected by damp and by water overflowing from ineffective rainwater goods. There is ivy growing over a large portion of the north east end of the building. There is a chimney at the north end of the building but it was not possible to assess its condition as it was fully covered in ivy

The building has a shallow pitched slate covered roof set at two levels for the high and low sections of the building. Both the pitched roofs have lightweight steel trusses supporting timber purlins and boards. The truss members appear to be in reasonable condition generally but there was damage near the leaking areas of roof. The condition of the slate roof is poor with slipped slates forming holes in many places. It is likely that the fixings for the slates have come to the end of their life as the holes appear to be caused by slippages not breakages of the slates. There is one roof light in the low roof that is entirely missing leaving a large hole in the roof. There is a timber lantern at the centre of the lower roof. The lantern is in very poor condition. It can be assumed that the leaks in the roof have caused damage to some of the timbers and boarding. The ridge capping appears to be intact and in reasonable condition. The guttering, down pipes and hoppers are in very poor condition.
