RAF Bicester  
Planning Brief  
**PART B 1**  
**CONSERVATION MANAGEMENT GUIDELINES**  
**DOMESTIC SITE**

RAF Bicester  
Planning Brief  
**PART B2**  
***DRAFT CONSERVATION MANAGEMENT GUIDELINES***  
**FLYING FIELD AND TECHNICAL SITE**

The buildings inspected are listed below with comments on their condition as seen. The buildings are listed in the order in which they were viewed and the degree of access to each is noted. The condition of the finishes, windows and doors is not noted except where it indicates an underlying structural problem. In general the windows are boarded up making assessment of the condition of the lintels very difficult.

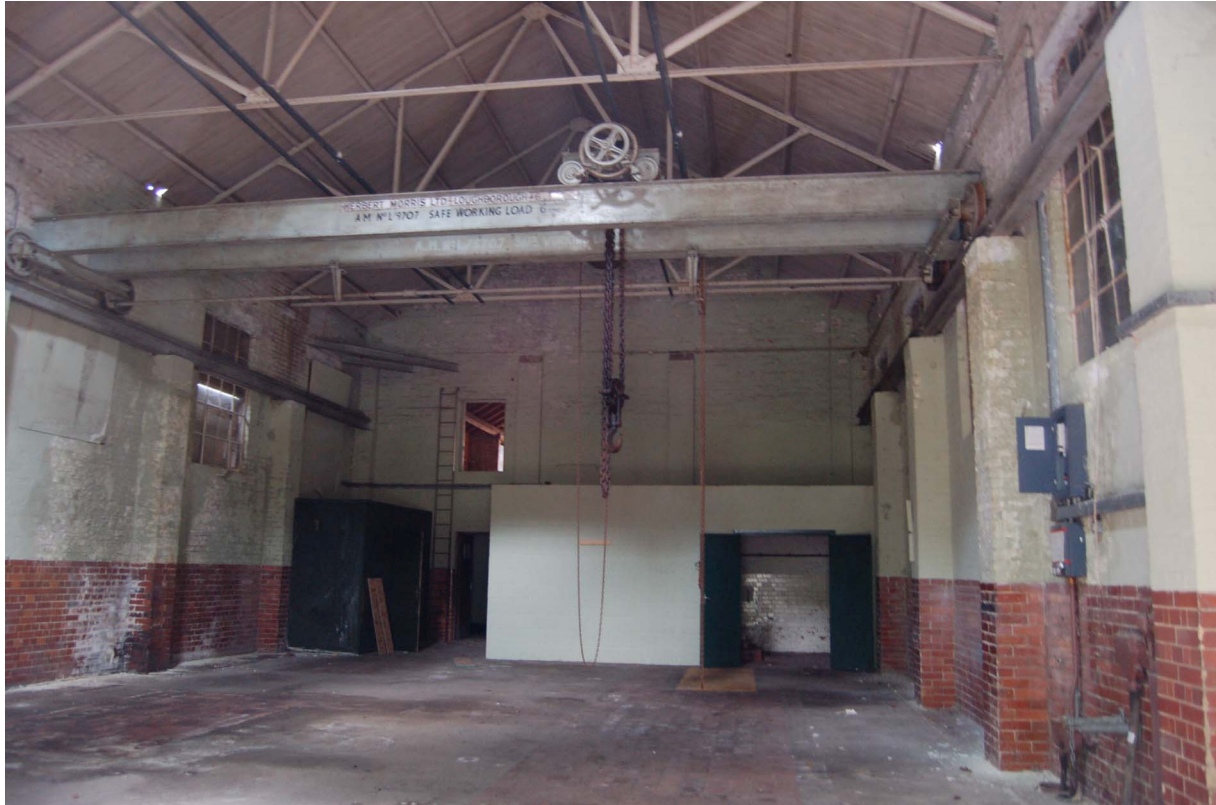
The condition of the internal faces of the external walls is moderate except in areas where there is damp penetration. The whole of the interior of the building is tiled up to about 1.2 m and is painted above that, the paintwork is in poor condition throughout. The floor is tiled in the areas observed and is in moderate condition.

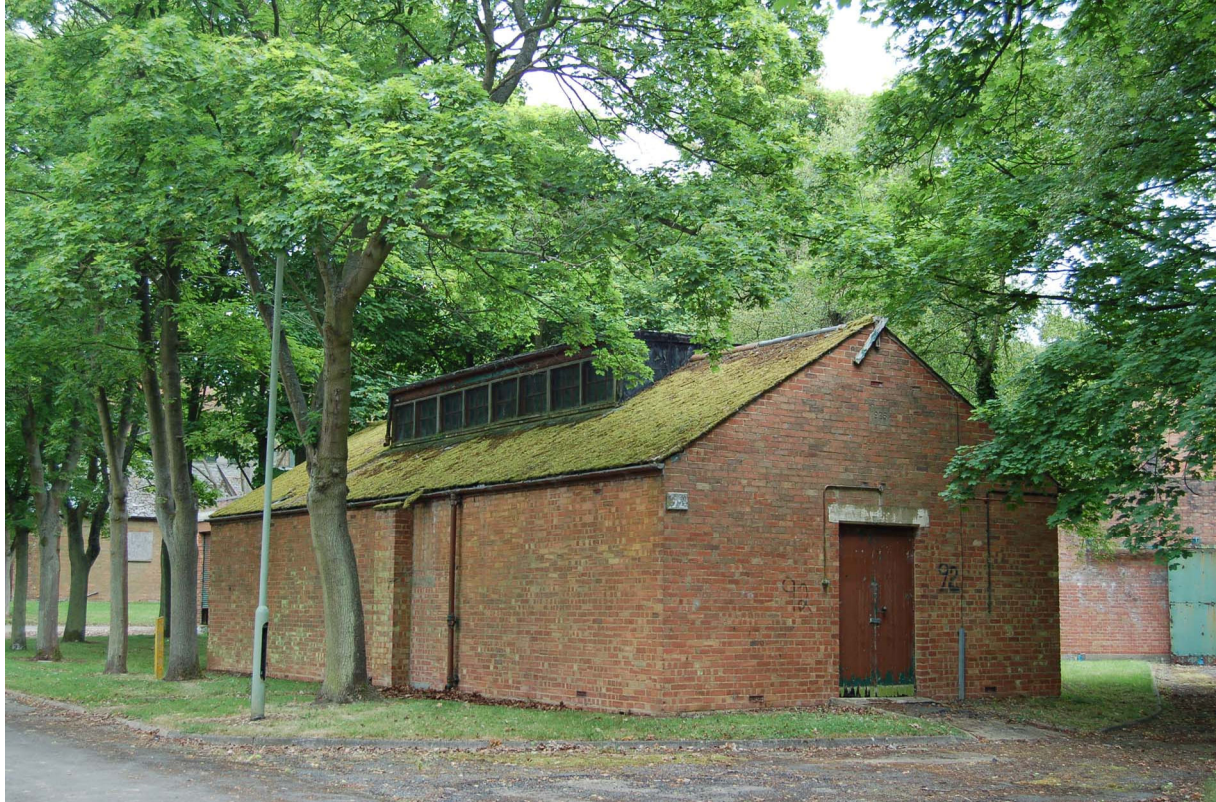
### **Building 92**

The Parachute Store appears to be in its original form with red brickwork cavity construction external walls that are generally in reasonable condition. The lintels and cills appear to be in moderate condition. The lime mortar is in reasonable condition.

The building has a shallow pitched slate covered roof with a large timber lantern. The roof is formed with timber rafters and purlins supported by timber trusses. The truss members appear to be in reasonable condition generally although they appear to be deflected adjacent to the lantern. The condition of the slate roof is moderate with a few slipped slates forming a few holes. It is likely that the fixings for the slates have come to the end of their life as the holes appear to be caused by slippages not breakages of the slates. There is a timber lantern at the centre of the lower roof. The lantern is in very poor condition and the flat timber roof over the lantern area was badly affected by water penetration. It can be assumed that the leaks in the roof have caused damage to some of the timbers and boarding. The ridge capping appears to be intact and in reasonable condition. The guttering, down pipes and hoppers are in reasonable condition.

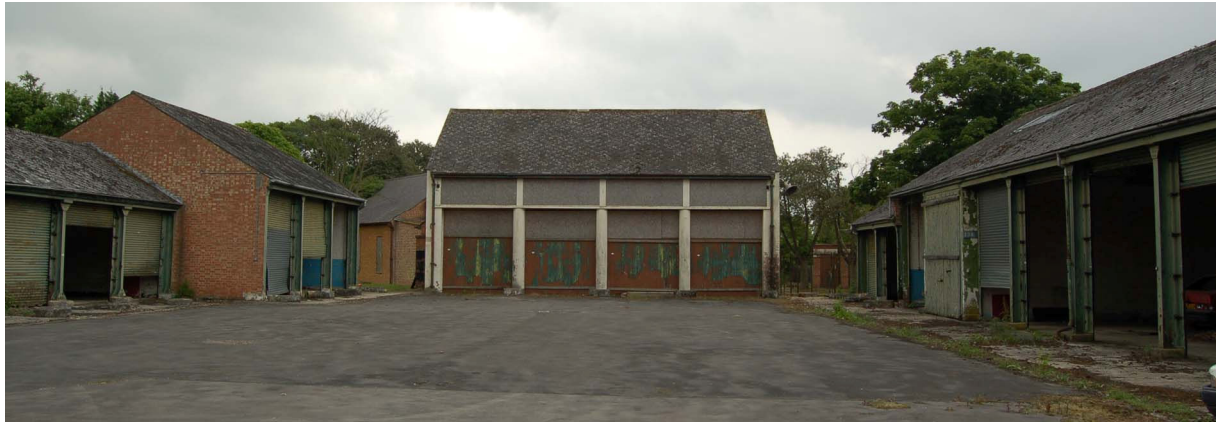
The Protected Long Bay and Motor Transport Sheds appear to be in their original form with solid red brickwork external walls that are generally in reasonable condition. The fronts of all the building have roller shutter doors. The front of the southern end of the Protected Long Bay has been stressed and has become detached from the gable walls at either end. The roller doors are supported by a steel frame that is fixed to the adjacent brickwork, this brickwork has a large vertical crack at each end. The lintels and cills appear to be in moderate condition. The lime mortar is badly eroded in some areas affected by damp and by water overflowing from ineffective rainwater goods. The steel frames supporting the roller doors and roof above are in poor condition with the bases of the columns being seriously corroded.

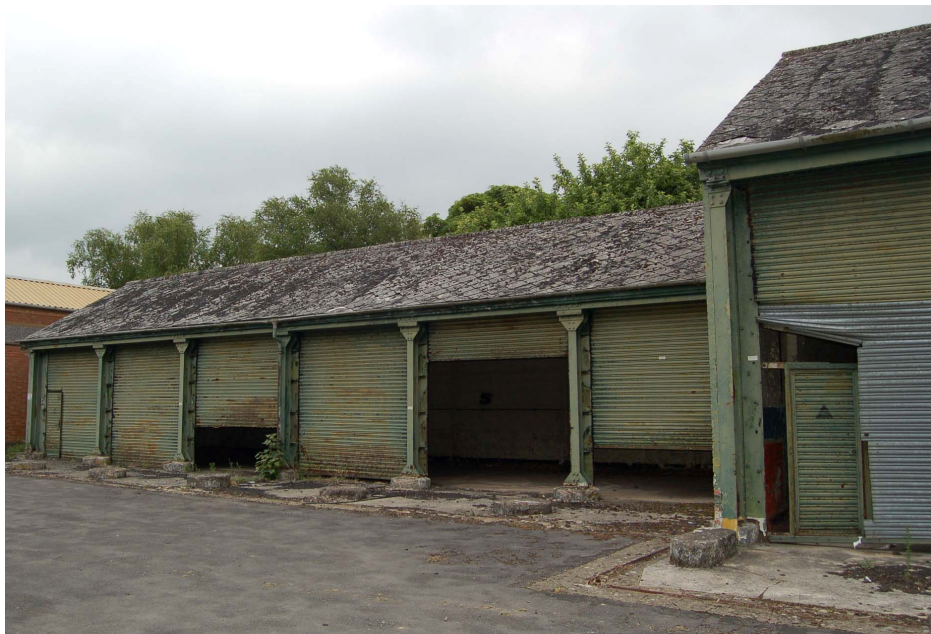
The buildings have shallow pitched slate covered roofs. The roofs have lightweight steel trusses supporting timber purlins and boards. The truss members appear to be in reasonable condition generally but there was damage near the leaking areas of roof. The condition of the slate roof is poor with slipped slates forming holes in many places. It is likely that the fixings for the slates have come to the end of their life as the holes appear to be caused by slippages not breakages of the slates. It can be seen that the leaks in the roof have caused damage to some of the timbers and boarding. The ridge capping appears to be intact and in reasonable condition. The guttering, down pipes and hoppers are in very poor condition.

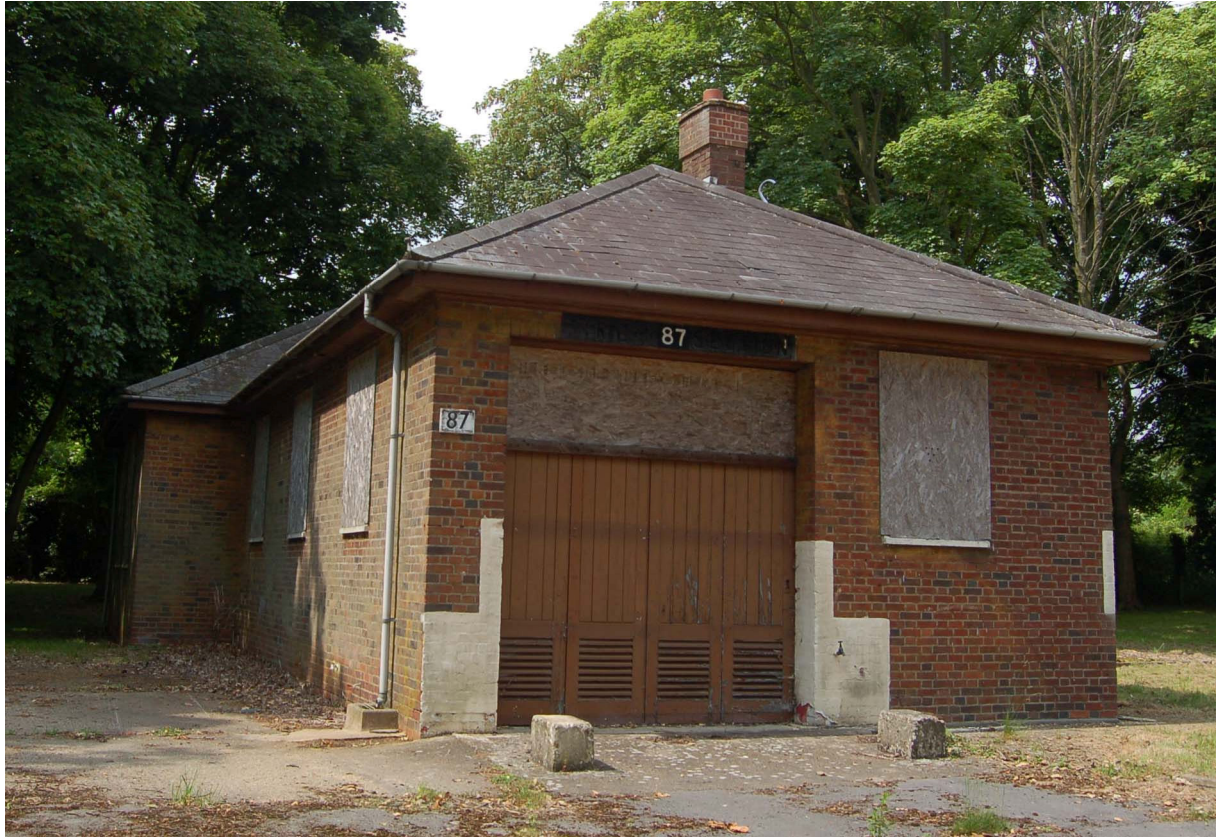
The Fire Party House appears to be in its original form with solid red brickwork external walls that are generally in reasonable condition. However very small vertical cracks were observed below the windows on three sides at the north western end. These do not appear to be structurally significant but may be caused by adjacent trees. The lintels and cills appear to be in moderate condition in most areas but a few concrete cills are deteriorating with sections missing of the face and underside. The lime mortar is in moderate condition. There is a chimney on the north east face that is in moderate condition although the top may be beginning to deteriorate.

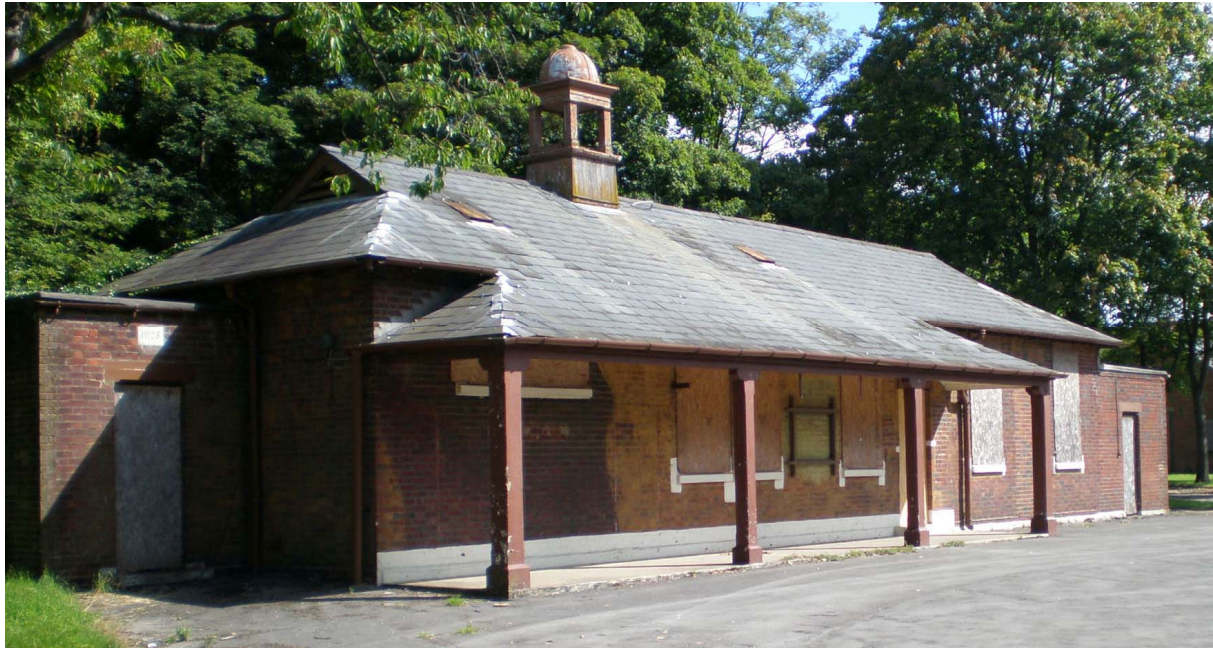
The Guard House appears to be in its original form with solid red brickwork external walls that are generally in reasonable condition. However vertical cracks were observed in the walls at the north west corner of the building very close to a tree. These appear to be being caused by the adjacent tree and do not appear to be structurally significant at present, however they are likely to continue to deteriorate and require repair in the future. The lintels and cills appear to be in moderate condition. The lime mortar is in moderate condition. There is a chimney on the north east face that is in moderate condition although the top may be beginning to deteriorate.

The small areas of flat roof could not be viewed but appear to be of asphalt on concrete construction. The guttering, down pipes and hoppers to the flat roofs appear to have been partly replaced and are in moderate condition.

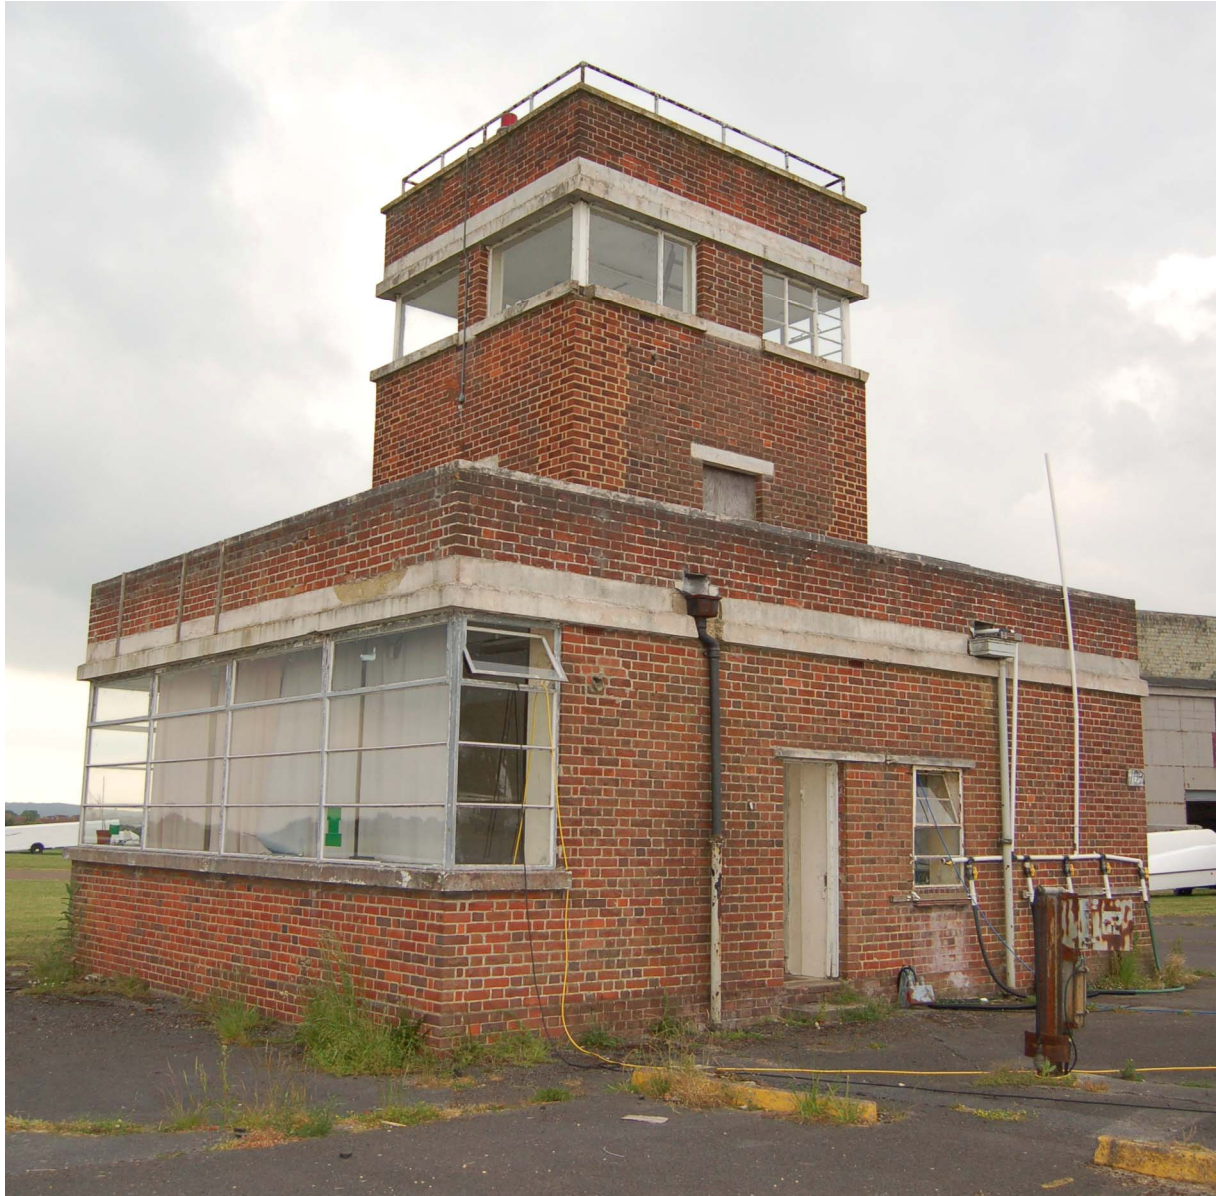
The Watch Office with Tower appears to be mainly in its original form with red brickwork solid external walls with concrete bands and detailing. The ground floor of the building has a concrete band at flat roof level with a brick parapet wall above. The lower part of the walls of the ground floor section is in moderate condition although there is some water staining and there are some frost damaged bricks. The parapet walls above are in poor condition. There are stepped cracks in some of the masonry at the parapet corners. There is a concrete capping detail and parts are damaged by frost. The concrete band course is in poor condition throughout with spalling of the surface in many locations with rusting reinforcement exposed in some areas. The mortar is generally in reasonable condition below the concrete band and in poor condition above. The concrete cills and lintels to the windows and doors are generally damaged and spalling. The upper floors are similar with significant failures in the concrete elements of the band courses and the cills and lintels being seriously damaged particularly on the top floor where there are parts missing and gaps up to 30 mm wide.
