Hanover Garden Flooding December 2013

Environment Agency Report

July 2014

This report explains the Environment Agency's role during flooding from the River Bure in Bicester, Oxfordshire on 24 December 2013. It sets out recommendations to reduce the risk of similar flooding in the future.

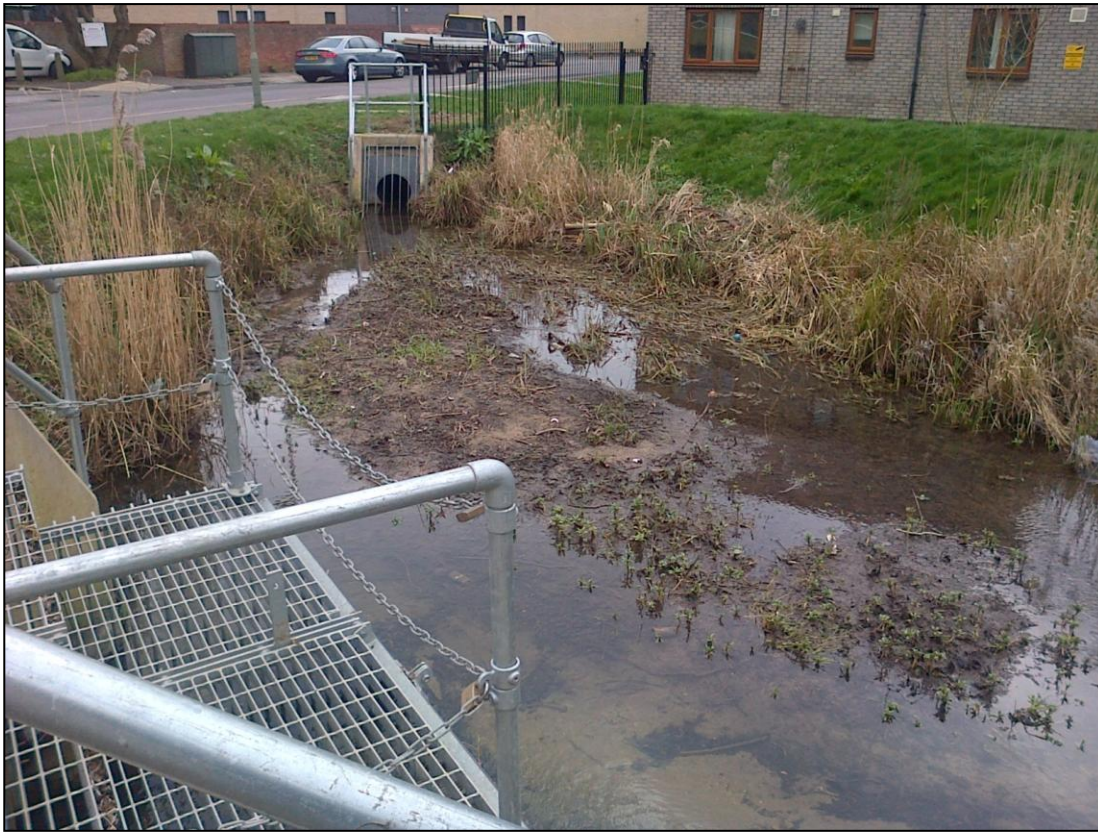
Figure 2: Trash screens at Hanover Gardens during normal flows looking south west towards the Back Brook culvert

| Recommendation | Description | Lead | Target date |
|--|--|--|---|
| Make improvements to trash screen at Hanover Gardens | It is likely that unseen debris on the trash screens at Hanover Gardens reduced the capacity of these culverts during the flooding. Oxfordshire County Council has already reduced the numbers of bars on the trash screen to reduce the risk of future blockages. A number of permanent improvements to the main trash screen have been agreed to reduce the risk of debris build up and improve maintenance access. Environment Agency consent for the works has been granted. | Oxfordshire County Council | Autumn 2014 |

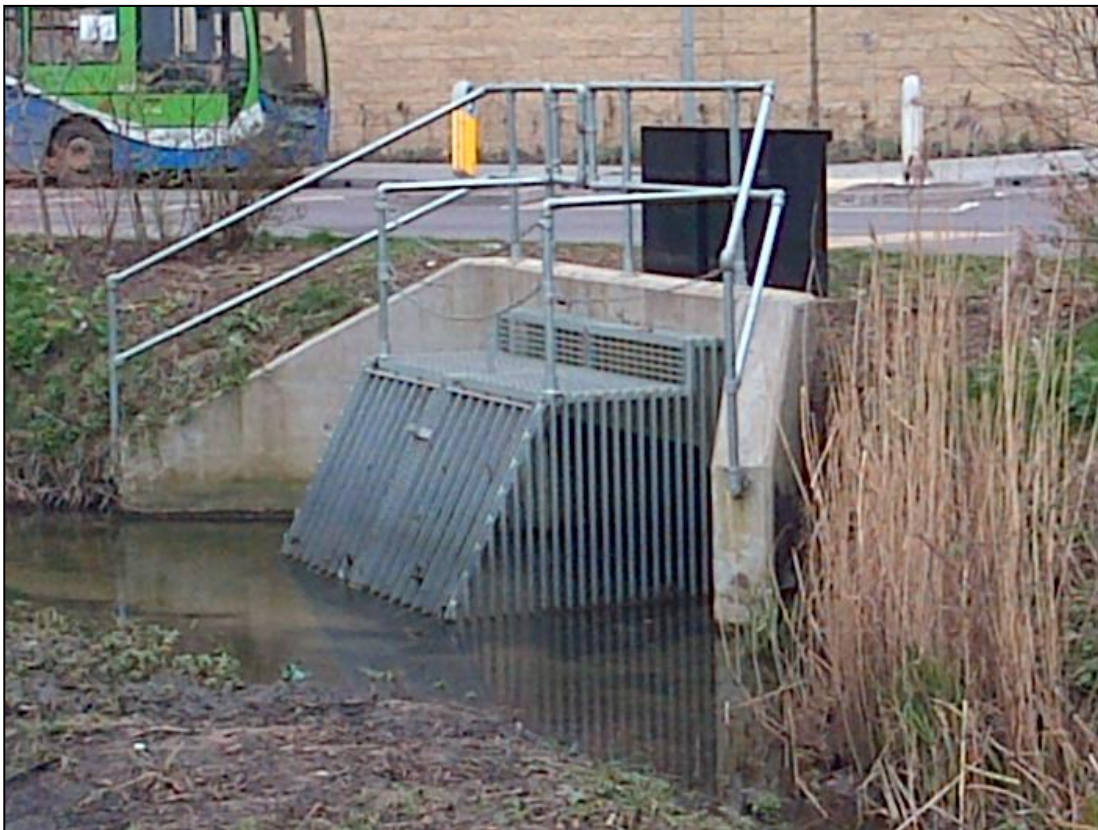
Figure 3: River Bure trash screen at Hanover Gardens during normal flows looking east

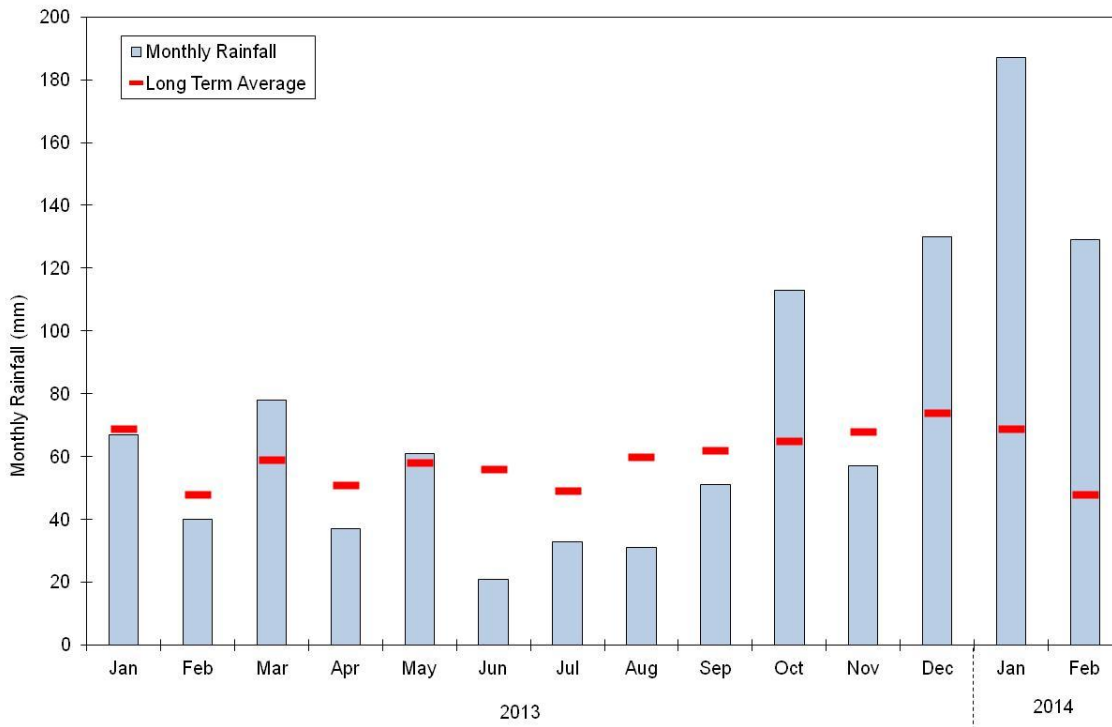
The rainfall recorded during December 2013 was above average for that month. By the end of the month the ground was starting to become saturated, any additional rainfall would lead to increased run off. During 23 December and the early hours of 24 December 28mm of rainfall was recorded at the Environment Agency's Bicester rain gauge. This caused water levels in the River Bure and other watercourses around Bicester to rise.

Figure 4: Rainfall in South East England January 2013 - Feb 2014

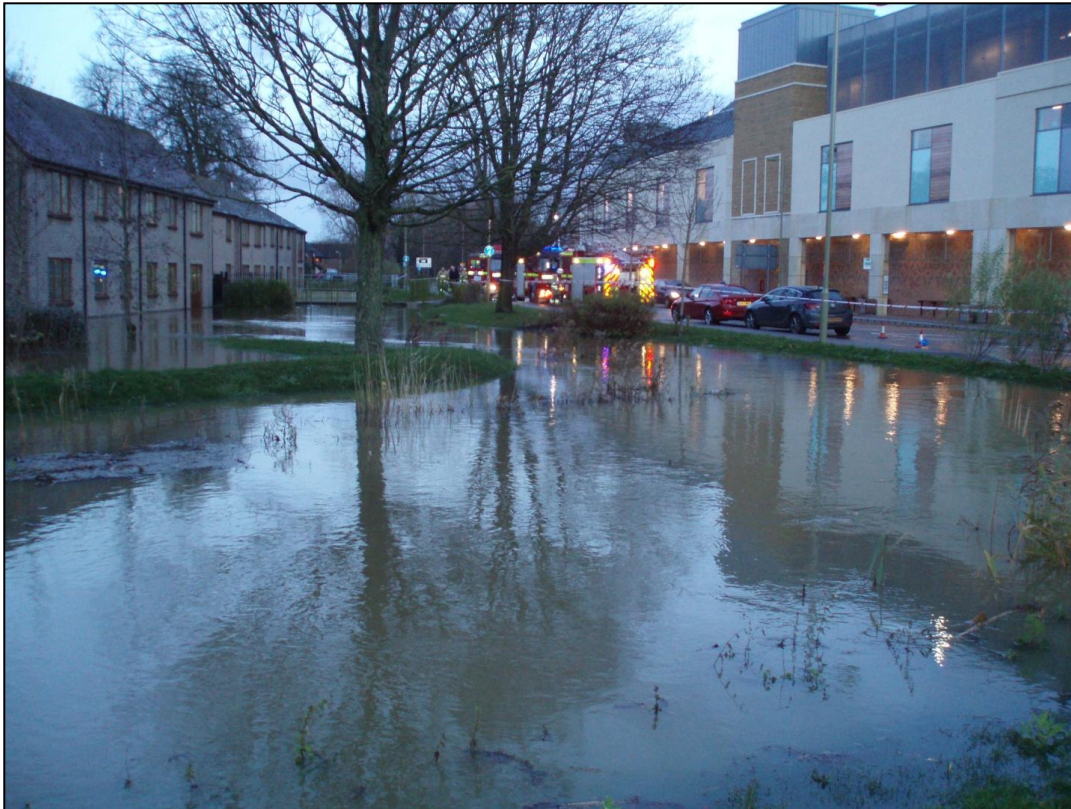
Following the removal of this debris, the water levels in the River Bure were observed to have dropped around the retirement home and the water started to return within banks.

Figure 5: River Bure out of banks looking north from Hanover Gardens towards Manorsfield Road

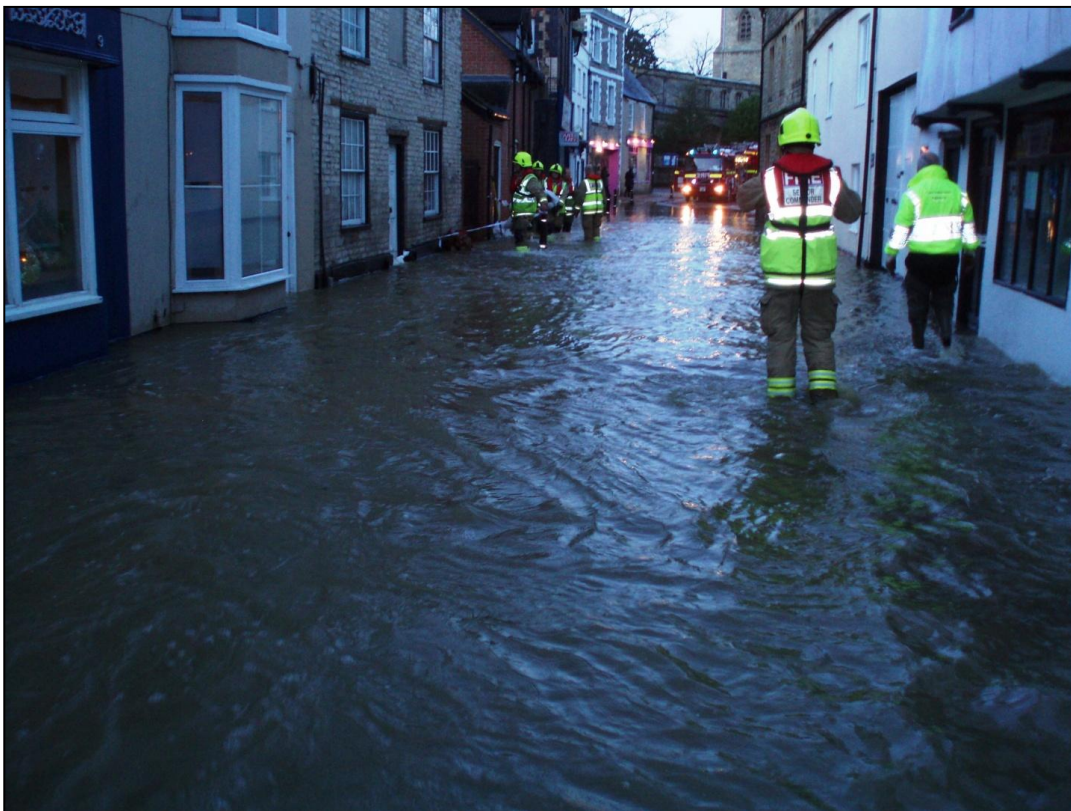
On arrival our team reported to the OFRS Officer in Charge. They were informed that OFRS had been in attendance since approximately 0400 that morning. The area around the retirement home was flooded with water flowing across the road at Hanover Gardens, across a car park and onto the adjacent road, named Causeway. OFRS had partially demolished a wall on the south side of Causeway to allow water to return to the Back Stream. OFRS stated they believed the gratings (trash screen) to the culverts beneath Hanover Gardens were clear and passing water. The evacuation of the retirement home had already taken place with some occupants being moved to higher floors.

Figure 6: Flooding along Causeway looking west

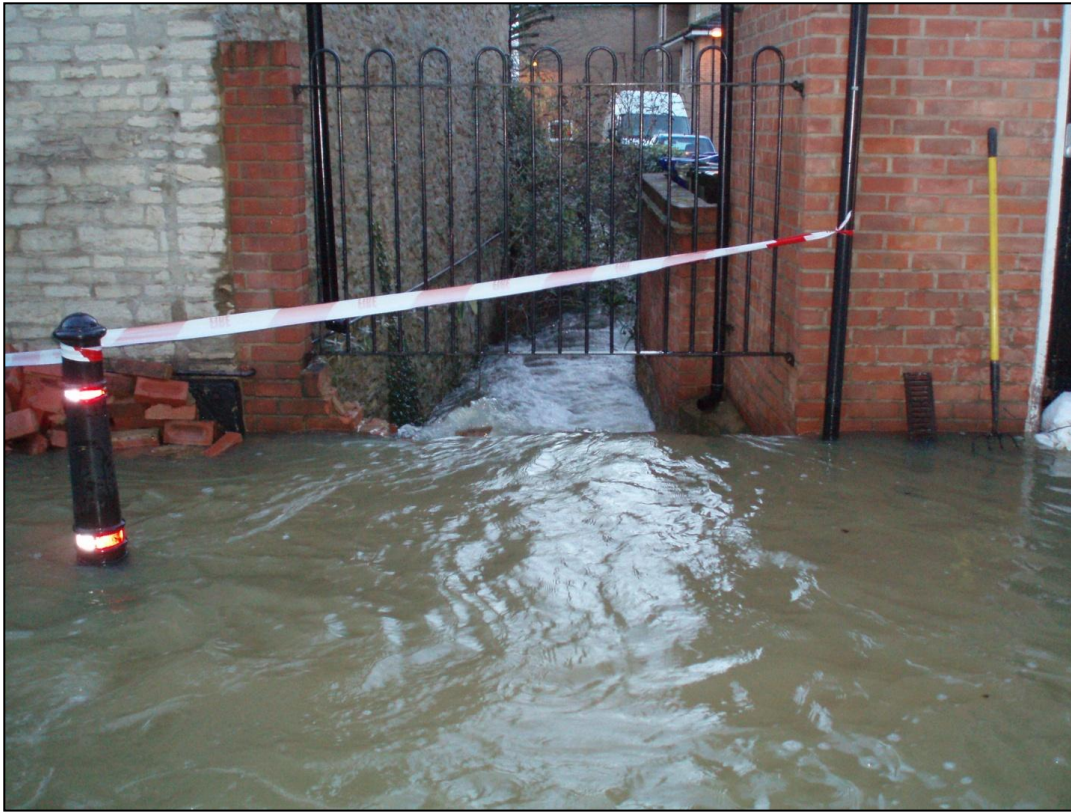
Figure 7: Section of wall removed on south side of Causeway by Oxfordshire Fire and Rescue Service to allow flood water to return to Back Brook

| Formalise spillway back into Back Stream | The wall in Causeway which was removed by OFRS to allow water to return to the Back Brook has not been rebuilt. It has been replaced with a pedestrian hand rail. This will reduce the risk of water backing up along Causeway. | Oxfordshire County Council | Complete |

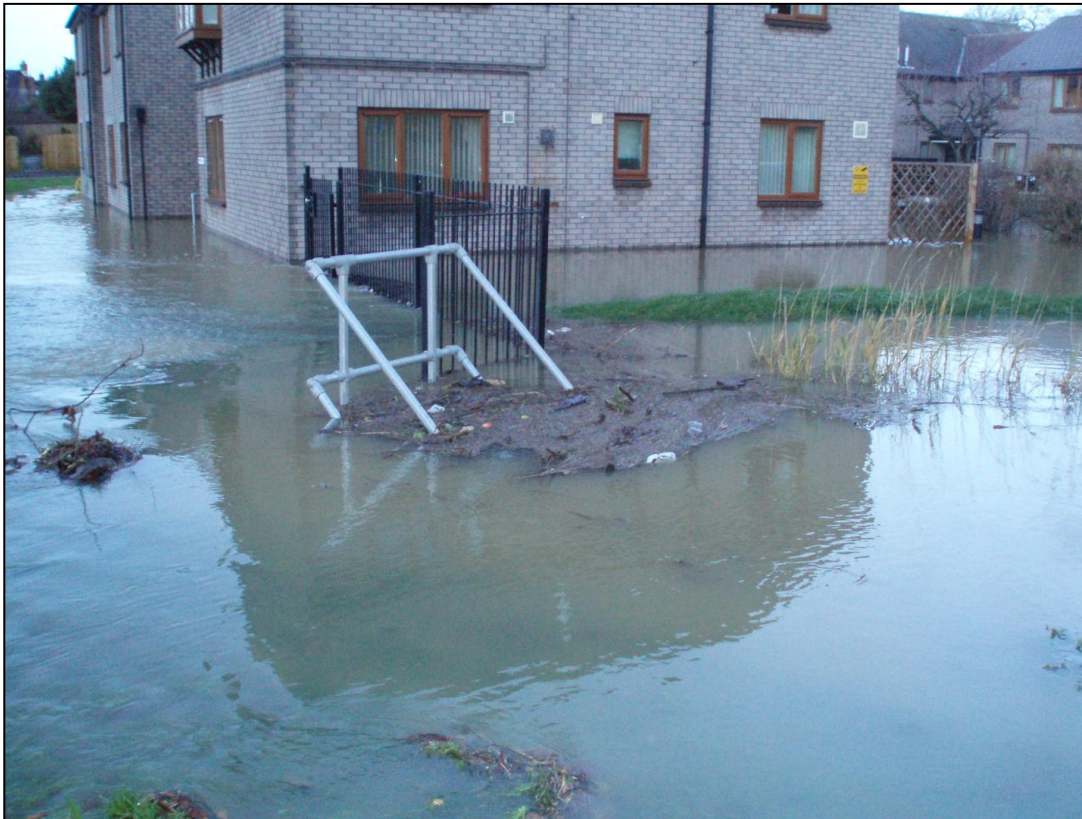
Figure 8: Guard rail of Back Stream culvert headwall surrounded by flood water

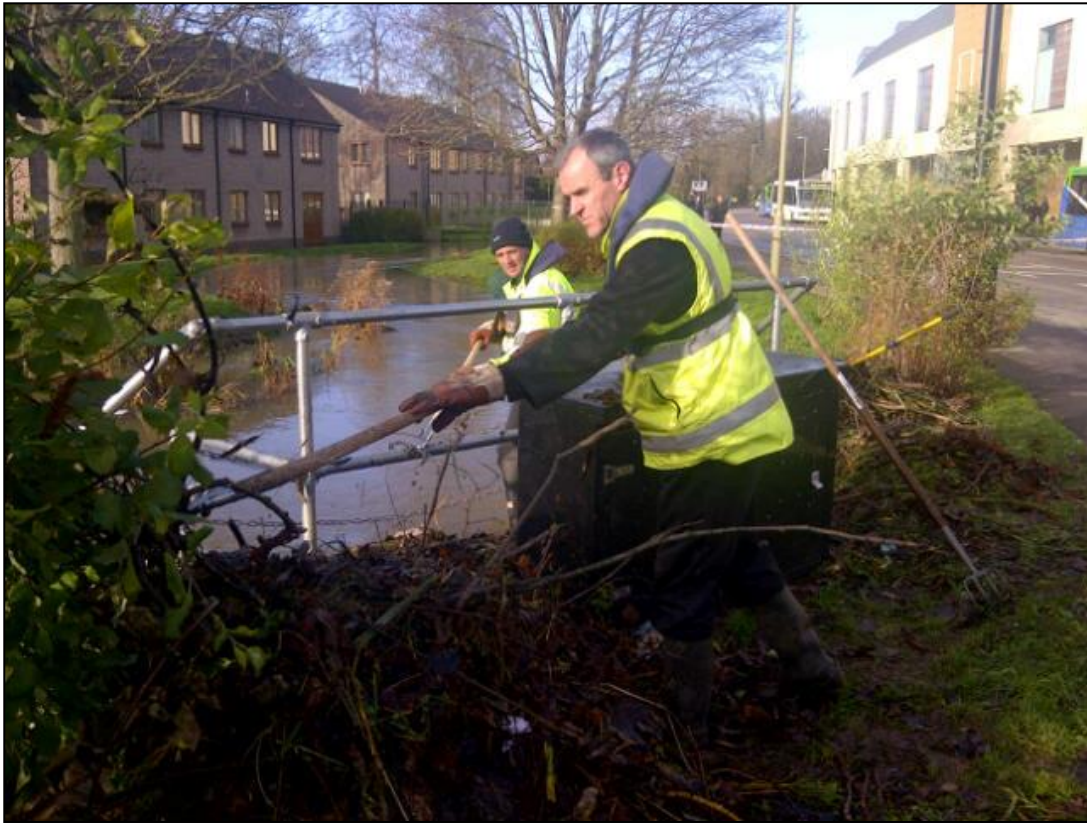
Our other team checked all the trash screens on the River Bure and Back Brook for blockages. At approximately 1100 this team successfully removed a large amount of debris from below the water level at the Bure trash screen at Hanover Garden. Our team also cleared trash screens downstream at Chapel Street & Priory Road.

Figure 9: Environment Agency operational team removing debris from the River Bure trash screen at Hanover Gardens

| Recommendation | Description | Lead | Target date |
|--|--|--|---|
| Continue regular inspection and debris clearance along River Bure | Regular inspection and maintenance of the watercourse is important to ensure it is clear of debris that could lead to blockages during floods. The Environment Agency carries out regular maintenance along the river but requires riparian owners to fulfil their responsibilities too. | Riparian owners and Environment Agency | Ongoing |
