Hethe Conservation Area Appraisal

February 2022

Planning Policy, Conservation and Design

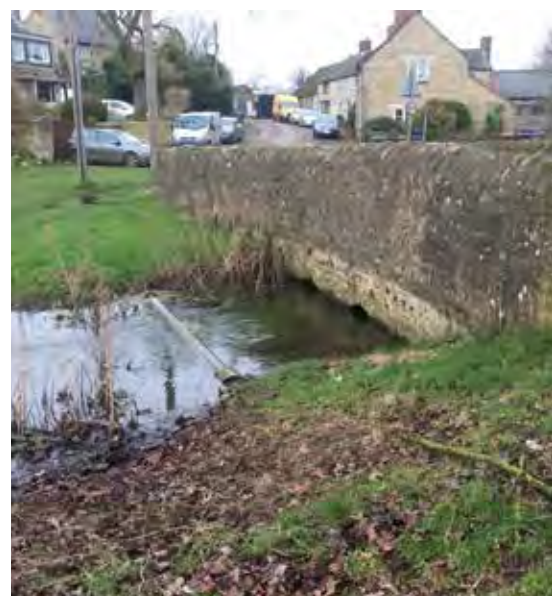
Water level of Hethe Brook under the bridge looking east, March 2020

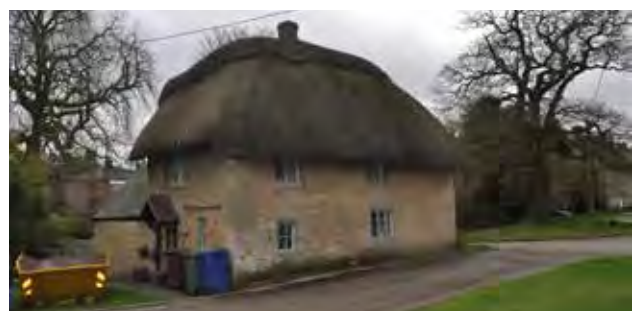
The roof form has been altered and the bay window has been removed and bricked up. The traditional flush ridge has been replaced by a block ridge which is not a traditional detail in the District.

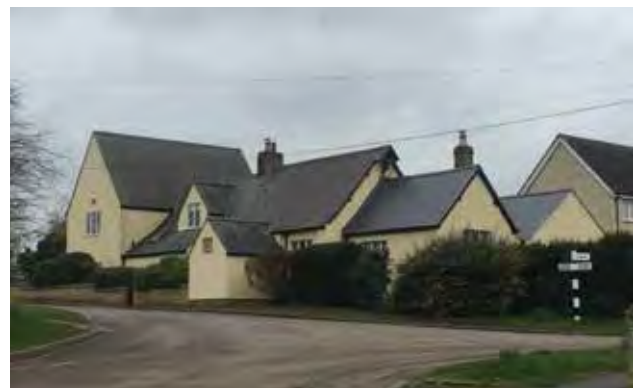
The school has been converted to a house. The school has been much extended and the masonry is now rendered.

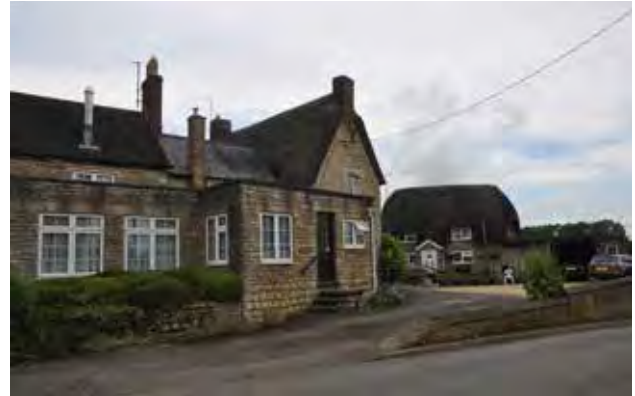
The small pitched roofed stone structure with chimney and the glazed lean-to have been replaced with an unsympathetic flat roofed extension. Flues and chimneys have also been added.

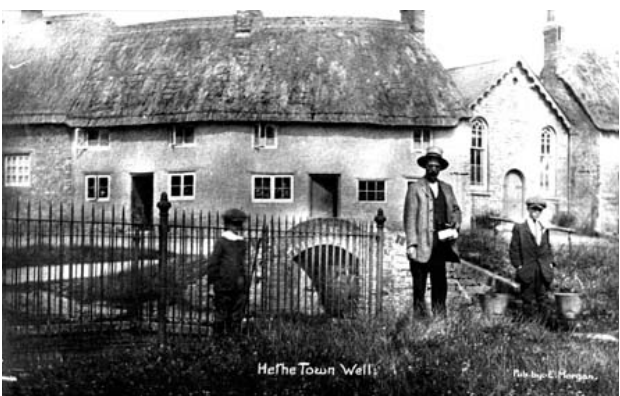
Originally 3 cottages: note the eaves height, the thatched roof and balanced flush casement window design on Knowle Cottage. The high proportion of solid wall to void opening is traditional in vernacular cottages in the district. Postcard 1900-1910. Copyright: OCC/E Morgan

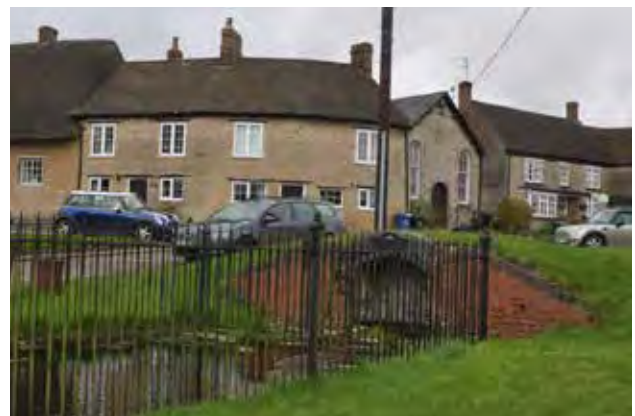
The three cottages are now in single ownership: Bow Cottage. The painted timber doors and window casements have been lost and the first floor windows have increased in size, as the eaves have been raised. The elevation now looks top heavy. The thatched roof has been replaced by tile. The gable chimney on the Old Post Office has been lowered.

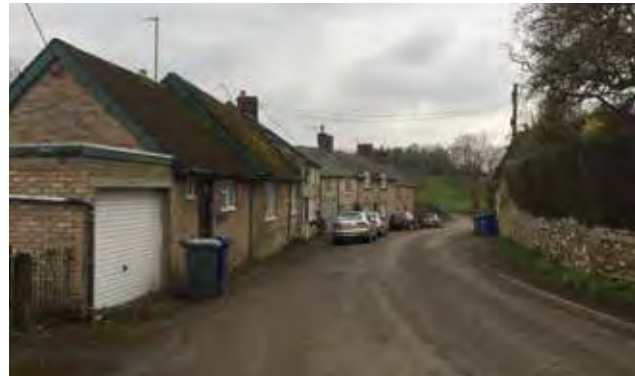
The sense of inclosure in the historic photograph of Main Street has been diluted with the loss of the cottages addressing the street to the north. The thatch has been lost completely in this part of the village.

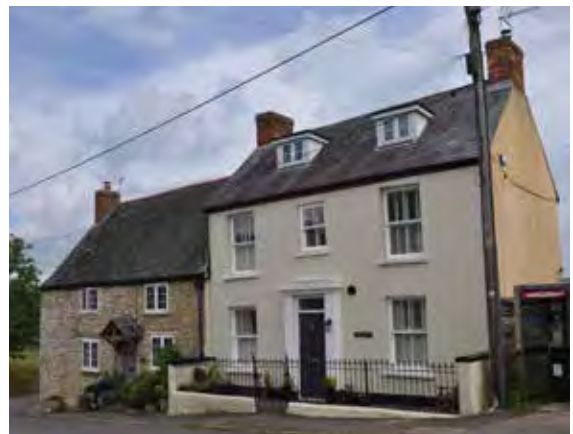
Springhill House has received a modern render which is painted to the front.
